Archaeological Reconnaissance Survey  
of Four Archaeological Sites  
on the Upper Mill River/Cushman Brook,  
Amherst, Massachusetts  
Volume II: Figures

Eric S. Johnson and Kathryn Curran

Prepared for the District One Neighborhood Association  
(DONA)

June 2023

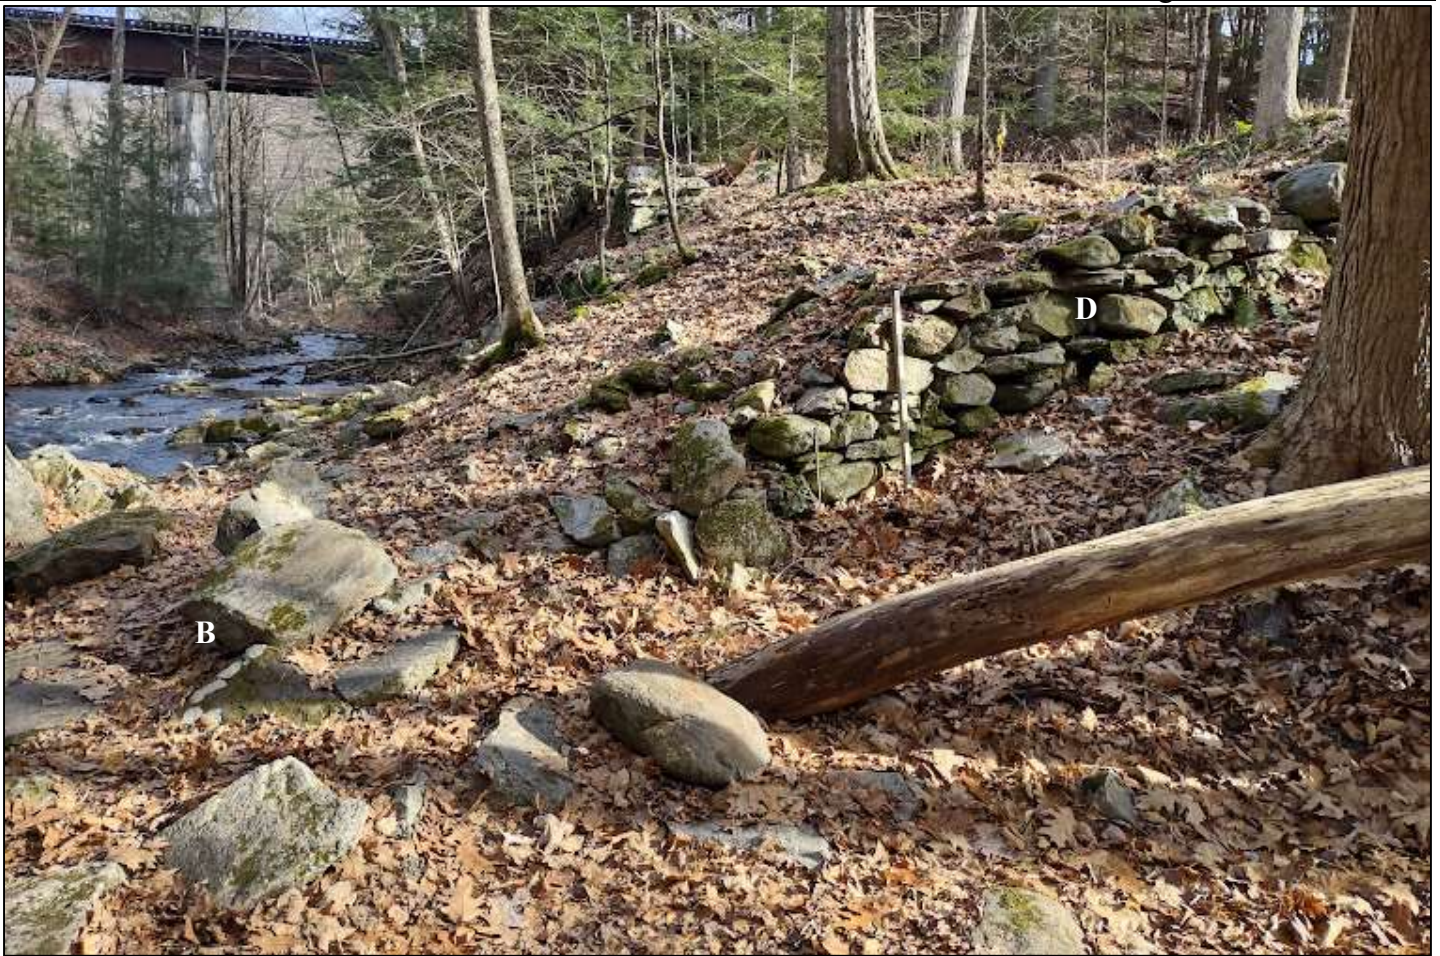
Figure 64. Looking east at the northern end of Wall D and the eastern end of Wall B. Both walls are badly deteriorated here, probably as a result of river action, although it is possible that upheaval of trees along the riverbank may have been responsible.

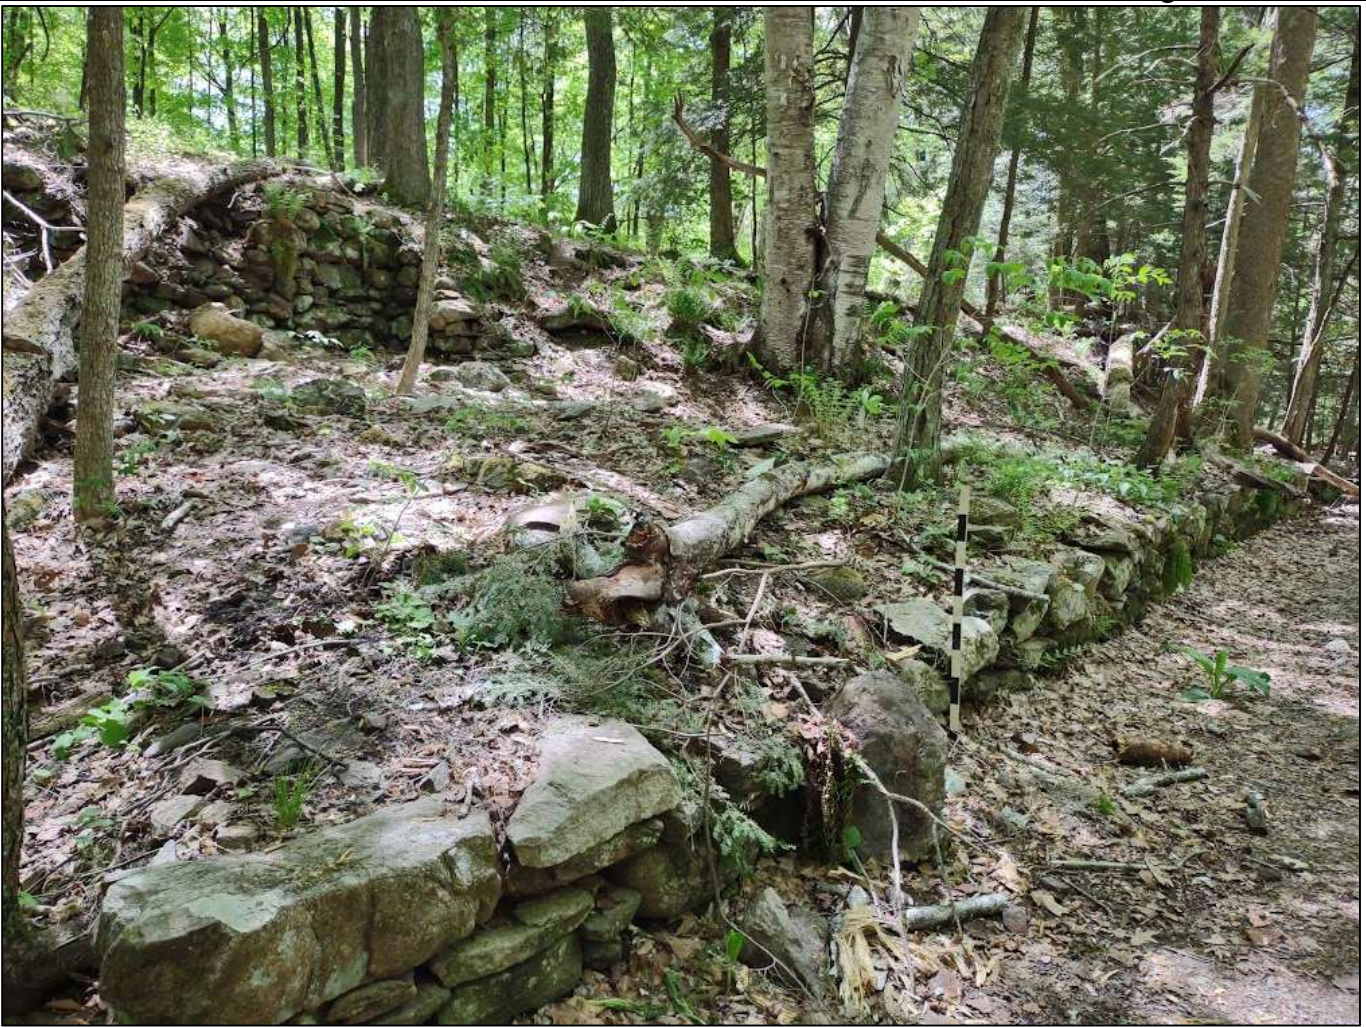
Figure 75. Looking southwest at a piece of Wall A that was recently damaged when a large branch from the birch tree in the background fell on it.

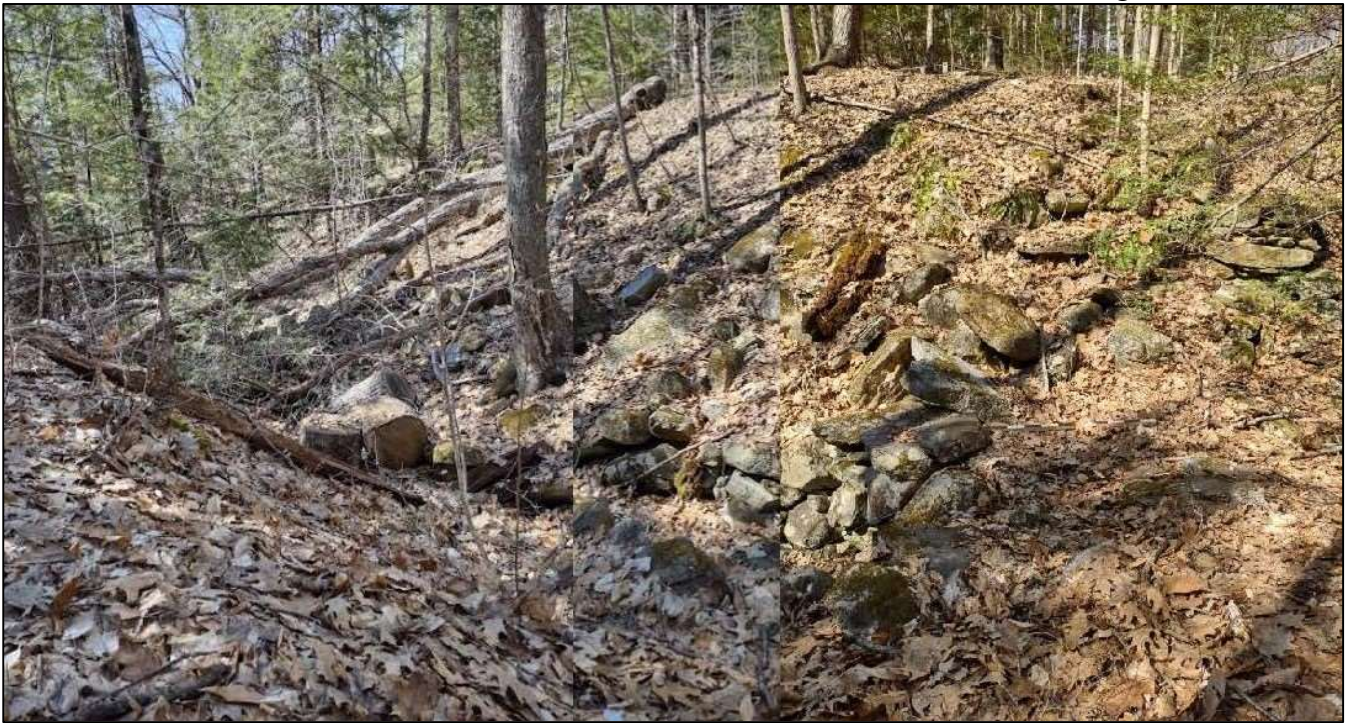
Figure 84. Composite of three photographs looking north, northwest, and west-northwest at the West Section. The disturbed condition of all but the eastern end of the north wall is evident, and any stonework that may have existed along the southern wall, apart from the eastern end, is not visible.

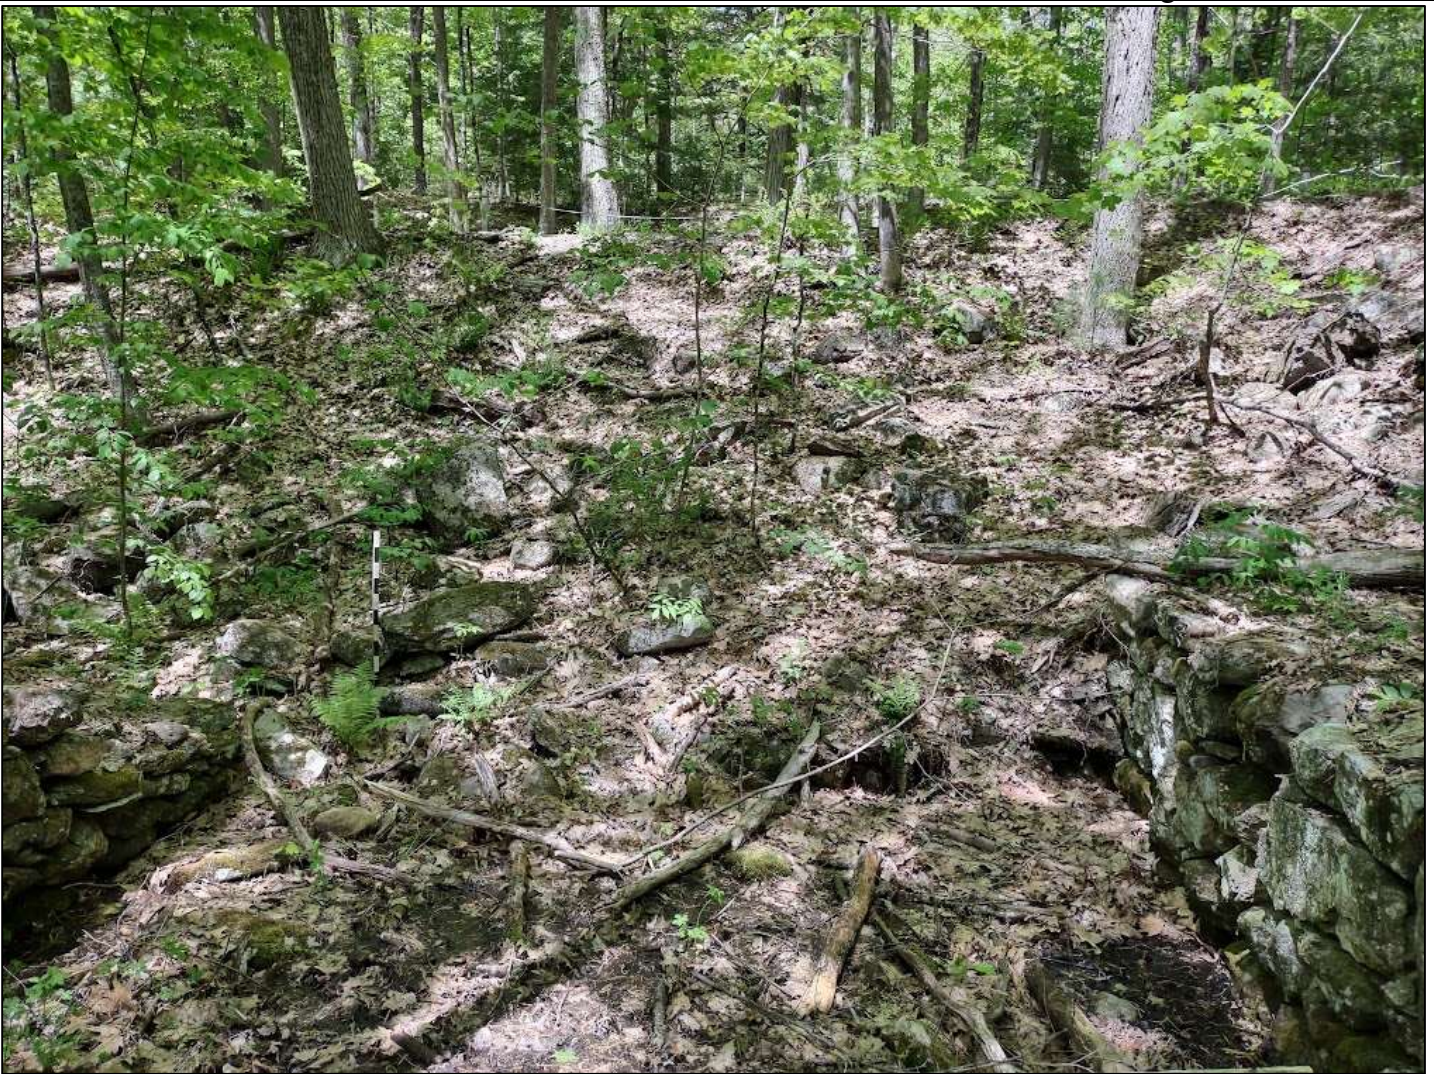
Figure 98. Looking north at the north side of the East Section showing the disturbed nature of this side.

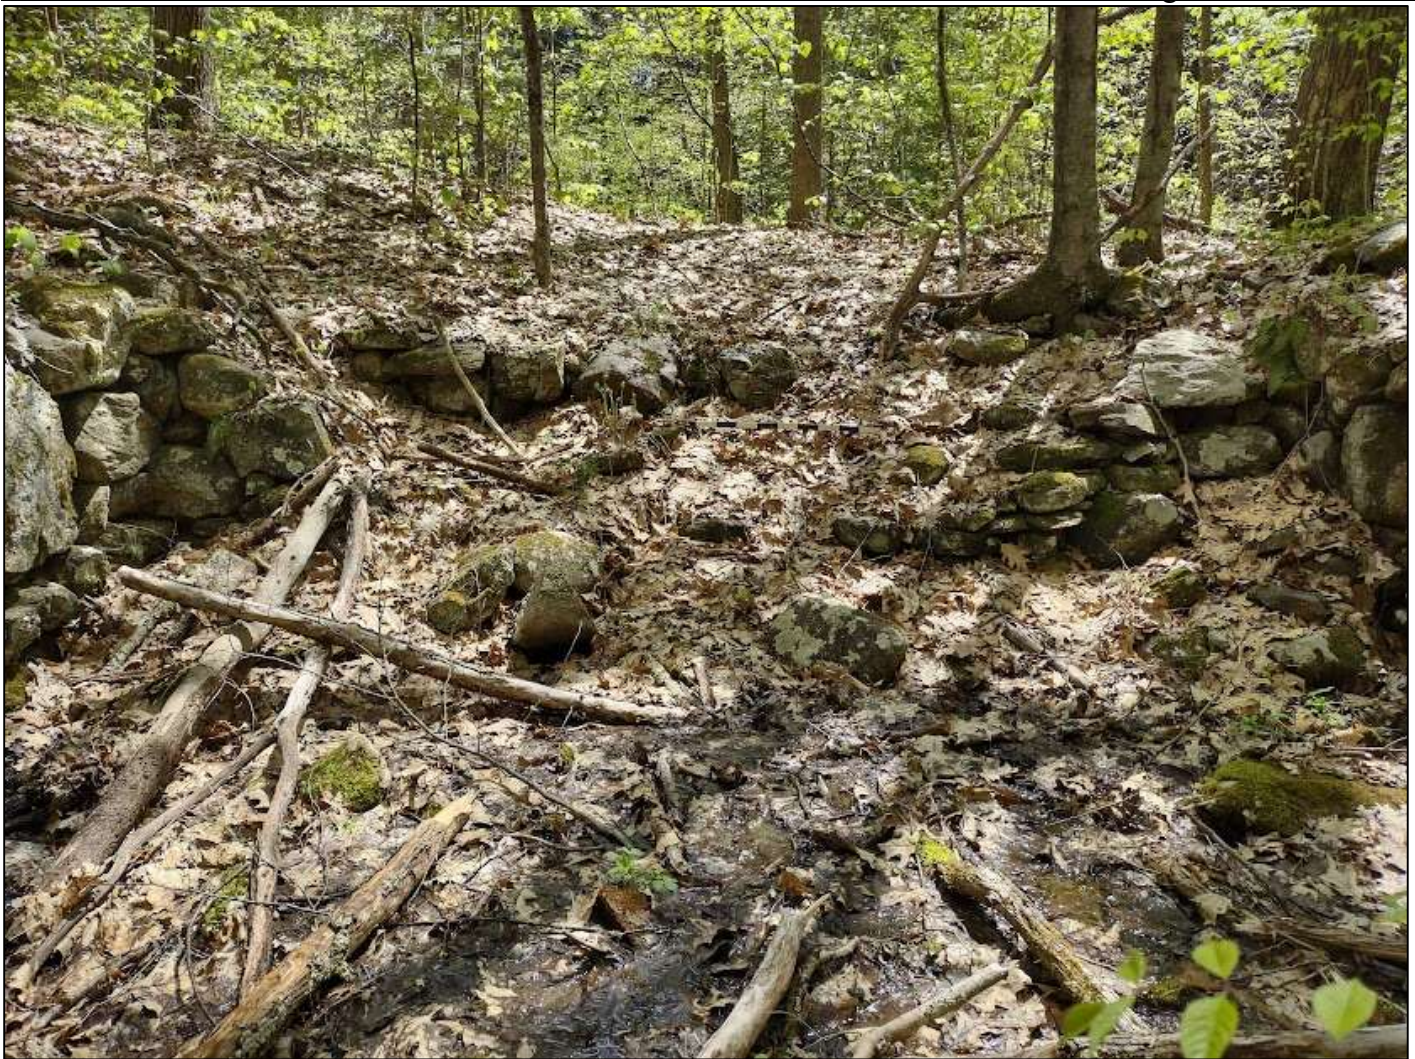
Figure 99. Looking south at the south wall of the East Section. The middle is deteriorated while the east and west ends retain more integrity. A lower wall appears to be backed by a higher wall.

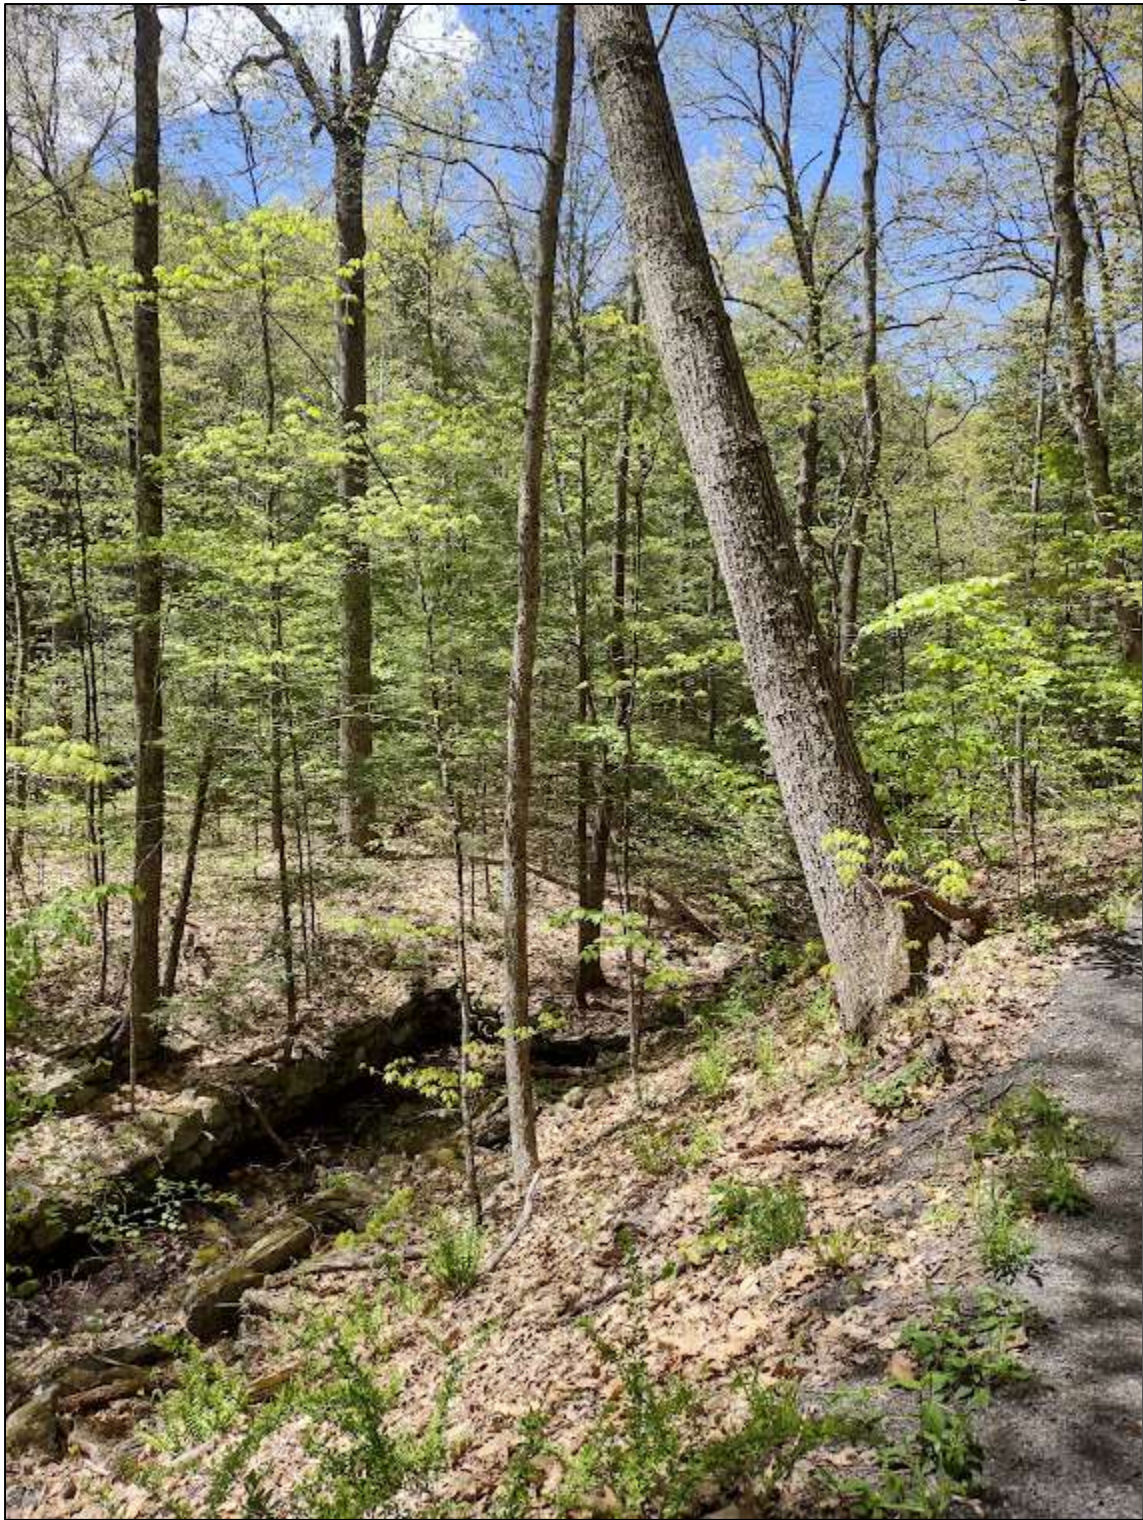
Figure 105. Looking east at a tree leaning over the Center Section of the Lower Roberts Mill site. When it falls it will land on the site with a destructive impact and unleash a small avalanche down the hill that will cover and damage parts of the site.
