Archaeological Reconnaissance Survey
of Four Archaeological Sites
on the Upper Mill River/Cushman Brook,
Amherst, Massachusetts
Volume I: Text

Eric S. Johnson and Kathryn Curran

Prepared for the District One Neighborhood Association
(DONA)

June 2023

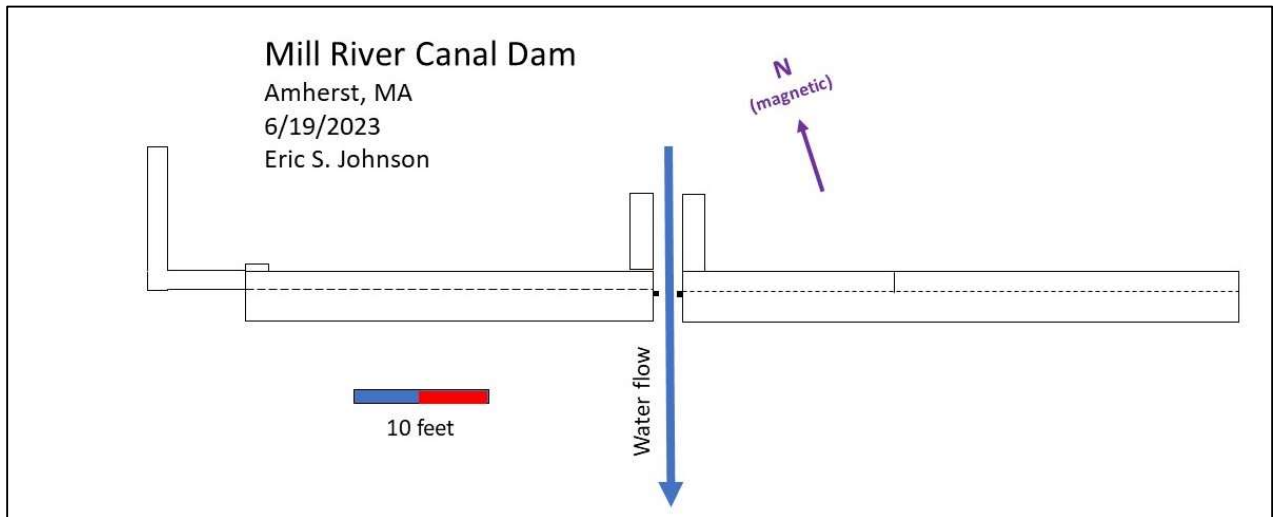
The Dam is a concrete and steel structure oriented approximately east-west (108°). It measures approximately 83 feet long. The west end of the dam is a pair of simple concrete walls that form a right angle measuring 18-20 inches in thickness. The west-central and east sections are dominated by concrete east-west walls with aprons extending to the south, which is the downstream side. These widen from 1½ feet along their tops to approximately 2 feet 3 inches thick at their bases. Their cross sections are essentially truncated isosceles triangles. In the map below they are indicated by the rectangles with dotted lines representing the south edges of their tops.

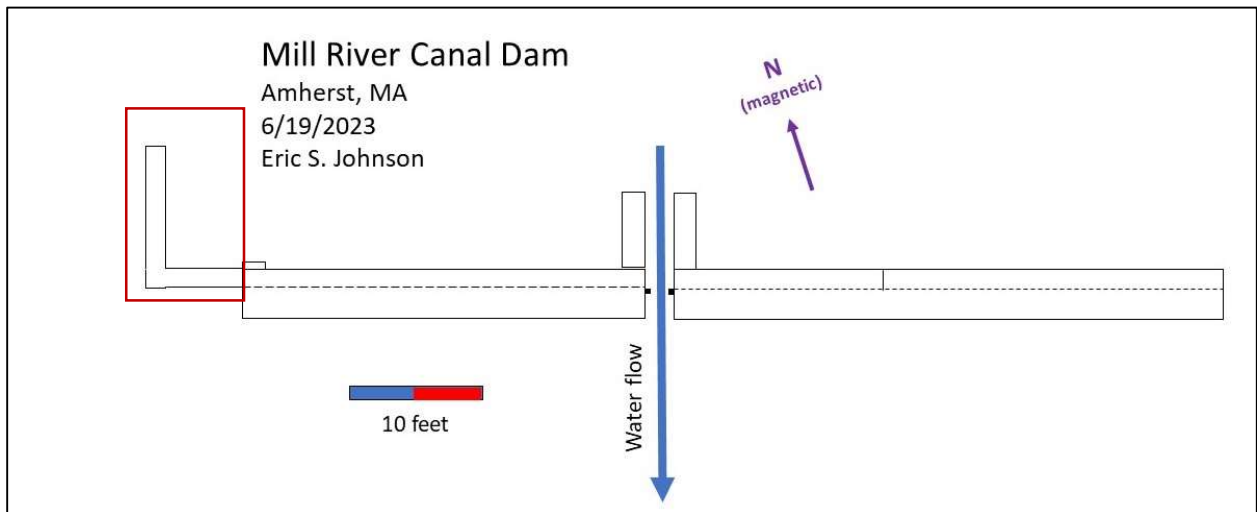
The West End of the dam is a right-angled concrete wall. At its northern end it is flush with the ground surface (Figure 37). Its north-south dimension as shown in the map below is a minimum length; it may extend farther to the north but is buried beneath leaves and soil.

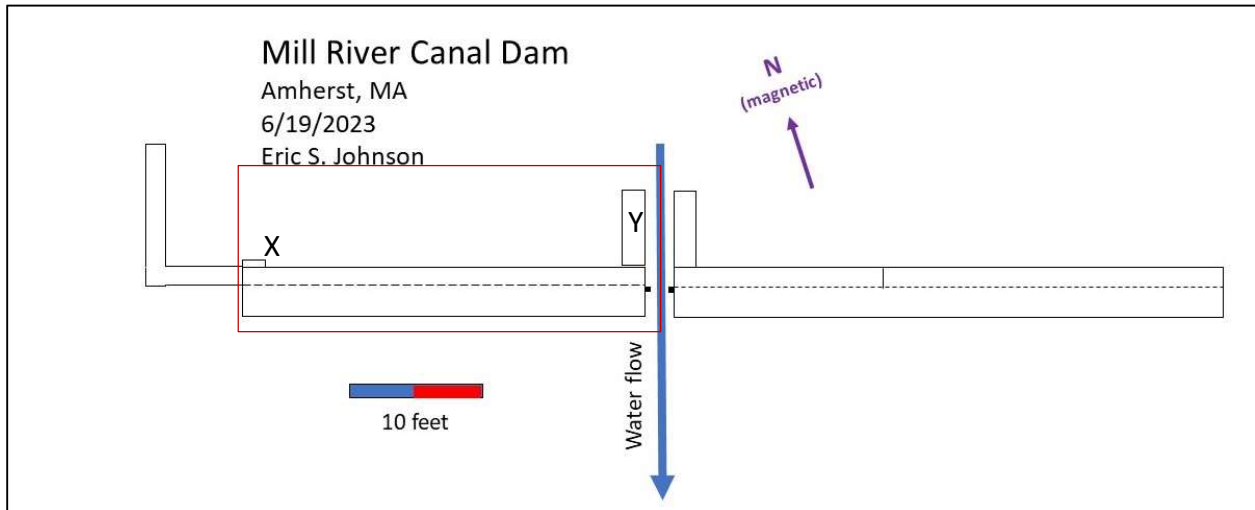
The West-Center Section extends from the east end of the West Section to the gap through which the small stream presently flows. The prominent feature of this section is a 30 feet 6 inches long, east-west wall. The wall is 17 inches thick along its top and has an apron extending south, so that it is 3½ feet thick along its base (Figures 38 and 39). At its western end, the wall is aligned with the wall of the west end but is lower by 14 inches (Figures 38 and 39). At this point a small wall, 21 inches thick (marked X in the map below), extends 7½ inches to the north.

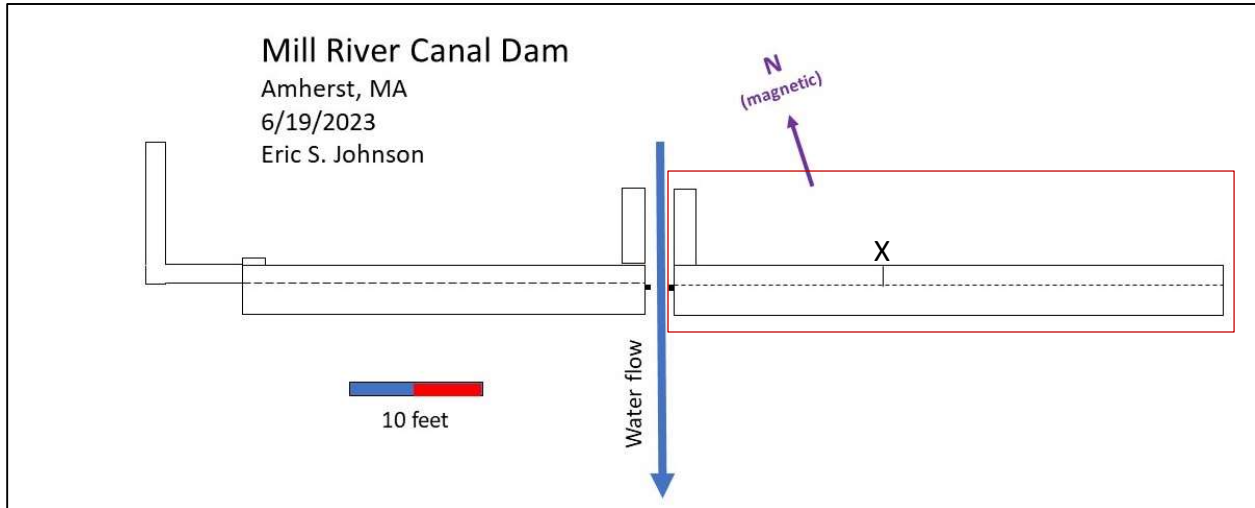
The East Section is nearly a mirror image of the West Center Section (Figures 42-44). It includes an east-west wall with a narrow top (18 inches) and a wide base, as well as a short wall extending to the north at the water gap and sloping down to the ground. The east-west wall is longer than its western counterpart (41 feet 8 inches as opposed to 30 feet 6 inches). It is also approximately 8-10 inches higher at the water gap. The point marked X in the map below marks a change in the height of the wall. To the west, the wall is 10 inches lower.

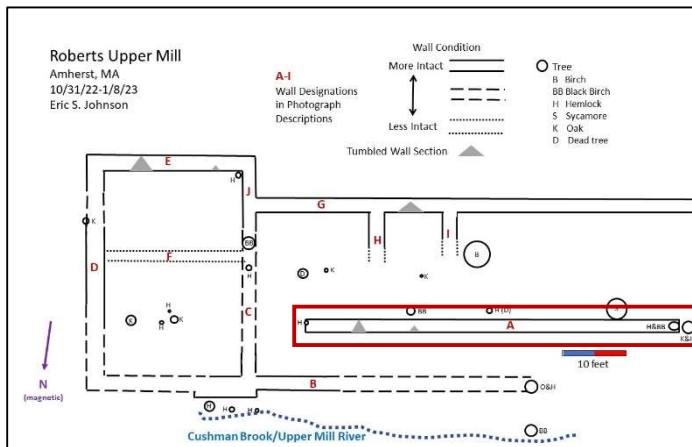
Wall A is the south side of the mill’s tailrace, through which water exited the structure after turning the mill wheel(s) and returned to the brook/river. It extends from the central portion of the site to the west a distance of 60 feet and its south side is built into the slope of the land. By that I mean that the wall is buried on its south side and exposed along its north side. Wall A is

generally well preserved, with only two small tumbled areas, one of which is a single fallen stone. Wall A is roughly two feet high along its 60-foot length. At its eastern end four courses of stone are visible. The top of the wall is partially to completely covered with vegetation and/or leaf litter along its entire length (Figures 53-57). Beyond the wall, to the west, there is a ditch, now filled with water to varying degrees, that is the continuation of the tailrace (Figure 52).

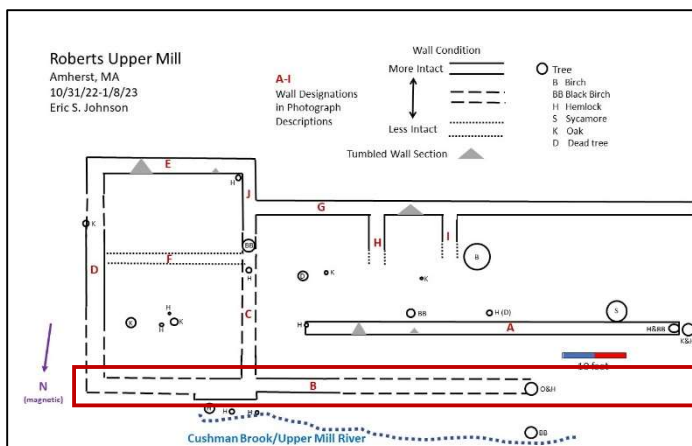
Wall B is the northern edge of the tailrace and, at its eastern end, may have supported a part of the mill’s structure. It forms the northern edge of the site and extends west from its junction with Wall D along the edge of the river/brook to the ditch to the west through which water exited the tailrace.

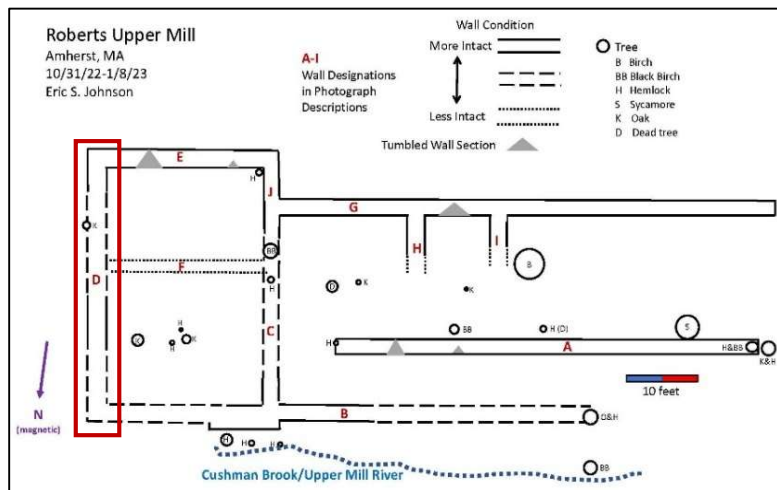
Wall D forms the eastern side of the site. The wall’s north end is a junction with Wall B and runs approximately 38 feet to its south end where it meets Wall E. It is a thick wall (4½ feet in places) that presumably supported the east side of the mill’s main structure. The present top of the wall follows the topography of the site, sloping down from south to north. (Figure 61). Wall D is fairly intact at its southern end where it meets Wall E (Figure 62). It also has a fairly intact central segment (Figure 63). The northern end (Figure 64) and a large part of the southern section (Figure 63 upper right) of the wall are disturbed or destroyed.

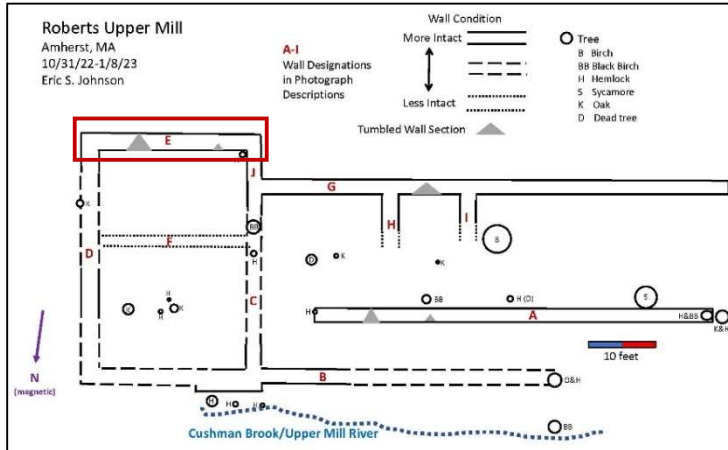
Wall E forms the southern side of the eastern part of the site. It spans 28 feet 8 inches from the west side of Wall D to the East side of Wall J (Figure 65). The length of the wall is noticeably bowed to the north (Figures 62, 66, and 67). It includes two tumbled areas where trees, erosion, or vandalism have dislodged stones from the wall. The eastern of these is located 5 feet 5 inches from the east end of the wall and is approximately 3½ feet wide. Here, stones have been

dislodged from the top to the bottom of the wall. A smaller disturbed area is situated 17 feet from the east edge and is about 16 inches wide. At this spot, stones have been removed either purposefully or by natural processes, forming a niche 16 inches wide and 18 feet high. Wall E is the highest wall at the site, standing as much as 5 feet 8 inches high on its north side. At its top, the wall is flush with or slightly elevated above the ground surface to the south (Figures 62, 65-67).

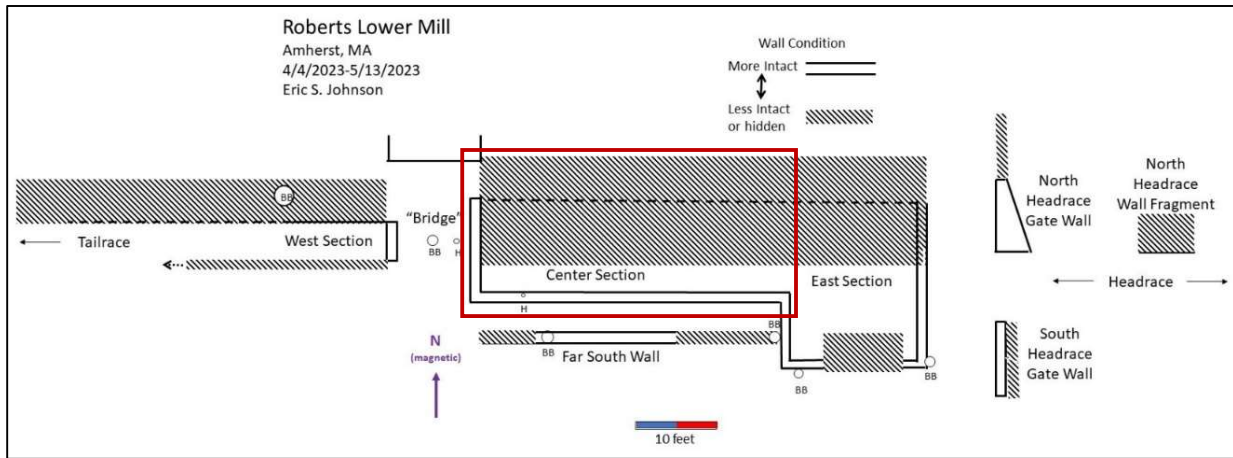
Center Section The Center Section, like the West Section, is a rectangle oriented roughly east-west (Figure 91). But the Center Section is more than twice as wide (12± feet), and its length (36 feet) is better defined. This section's south wall is fairly well-preserved (Figure 92). In its southwest corner (the right side of Figure 92) it measures approximately 2 feet 11 inches high. Its highest point, marked by a red X in Figure 92, is 3 feet 6 inches. The south wall is lowest (2 feet 1 inch) at its eastern end, where it meets the west wall of the East Section. The north wall shows some partially intact stonework as well as many tumbled and scattered stones (Figure 93). One possible explanation for this condition is that earth and stones dislodged in construction of or improvements to the Robert Frost Trail covered and/or dislodged parts of the north wall, making it impossible to measure the height of the north wall with reliable accuracy or precision.

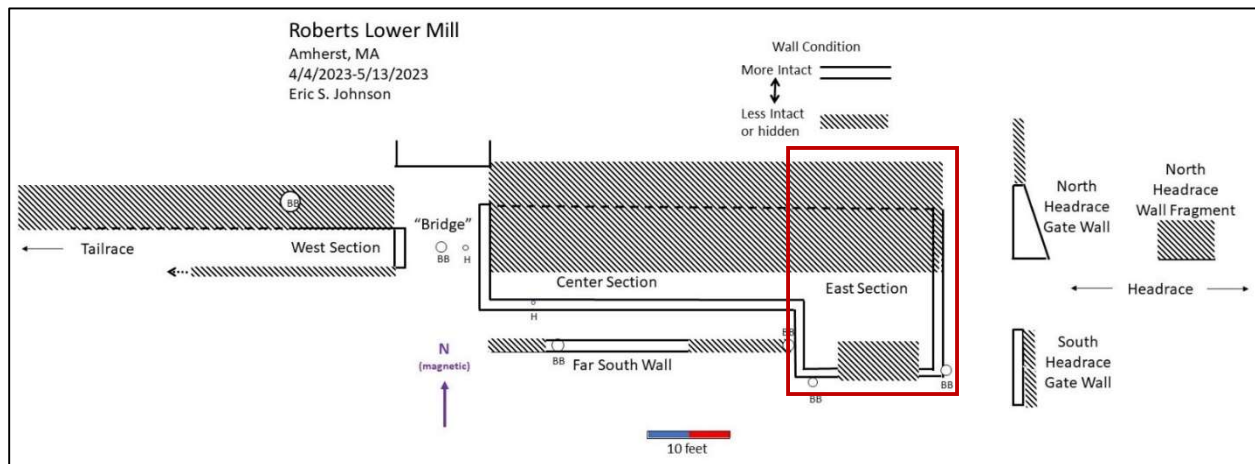
East Section The East Section is a 16-foot (east-west) by 18-foot (north-south) rectangular enclosure. It is the widest north to south of the three sections and is upstream of the two others (Figure 95). This is where water from the headrace would have entered the mill to turn a wheel and/or a turbine. A second or third floor above would have supported machines for shredding and processing rags, straw, or leather, for mixing the shreds with a liquid and/or pressing the sheets of paper product. As with the other sections, the degree of integrity of the walls of the East Section are variable. The floor is filled with leaves, fallen branches, a few large stones, and mud (Figure 96). Vertical measurements from the present surface of the floor must therefore be approximate. On March 10, 2023, a large rat snake and a wriggling ball of garter snakes were observed on the floor (Figure 97). The floor slopes upward to the north, again indicating the likelihood that stones and earth have fallen or been pushed down the slope from the Robert Frost Trail. The north side of the East section is a tumble of rocks (Figure 98).

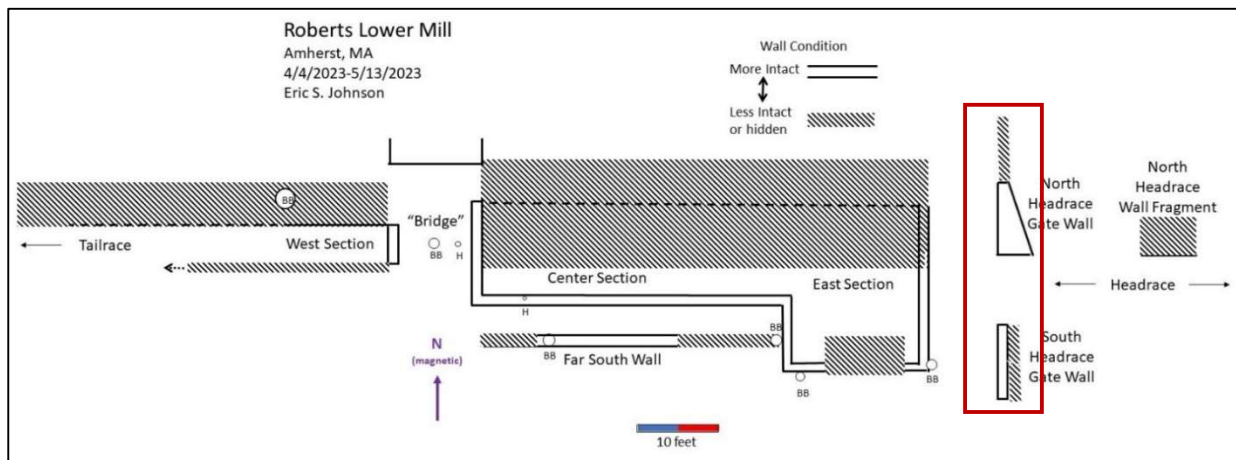
Headrace Gate Walls East of the East Section are two small, sturdy walls, separated by a gap of 9 feet (Figure 100). These likely are parts of an adjustable gate that regulated the flow of water from the headrace into the mill proper. The north gate wall (Figure 101) extends some distance (approximately 8 feet) to the north beyond where its stones are visible. At its southern end it is approximately 7 feet wide and stands approximately 2 feet 6 inches high. The southern Headrace Gate Wall (Figure 102) emerges from a large mound of earth to its east and south so its true dimensions cannot be determined.

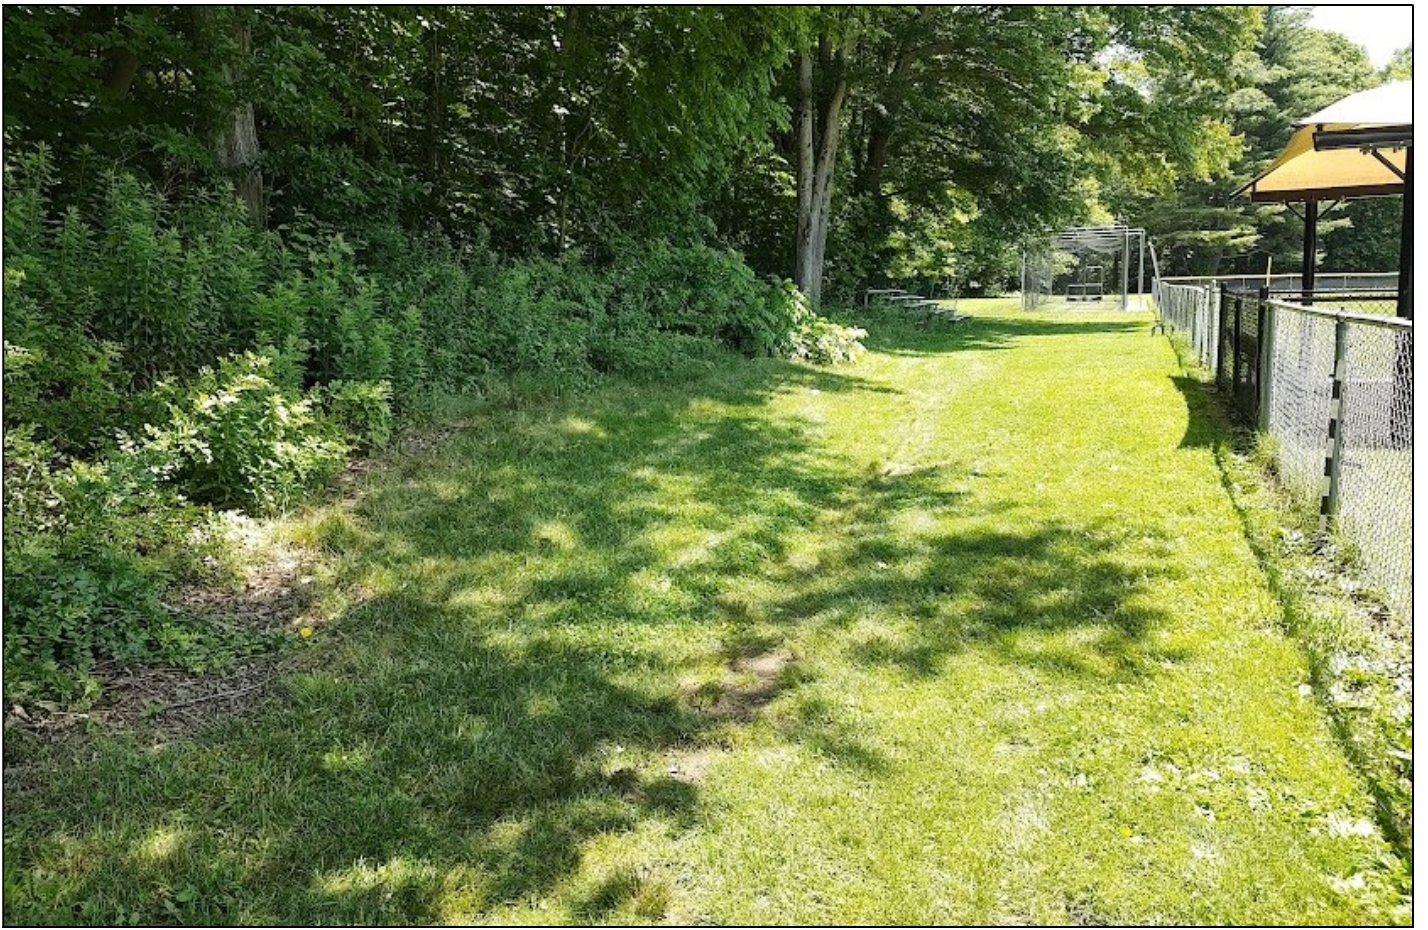
Upper Mill River Canal and Dam Site

Looking east (95°) at the berm that forms the south side of the canal from the northwest corner of the fence surrounding the baseball field. From the fence corner to the edge of the berm measures $12\frac{1}{2}$ feet at a bearing of 40° . The 1-meter measuring stick is placed against the fence on the right. Eric Johnson, June 19, 2023.

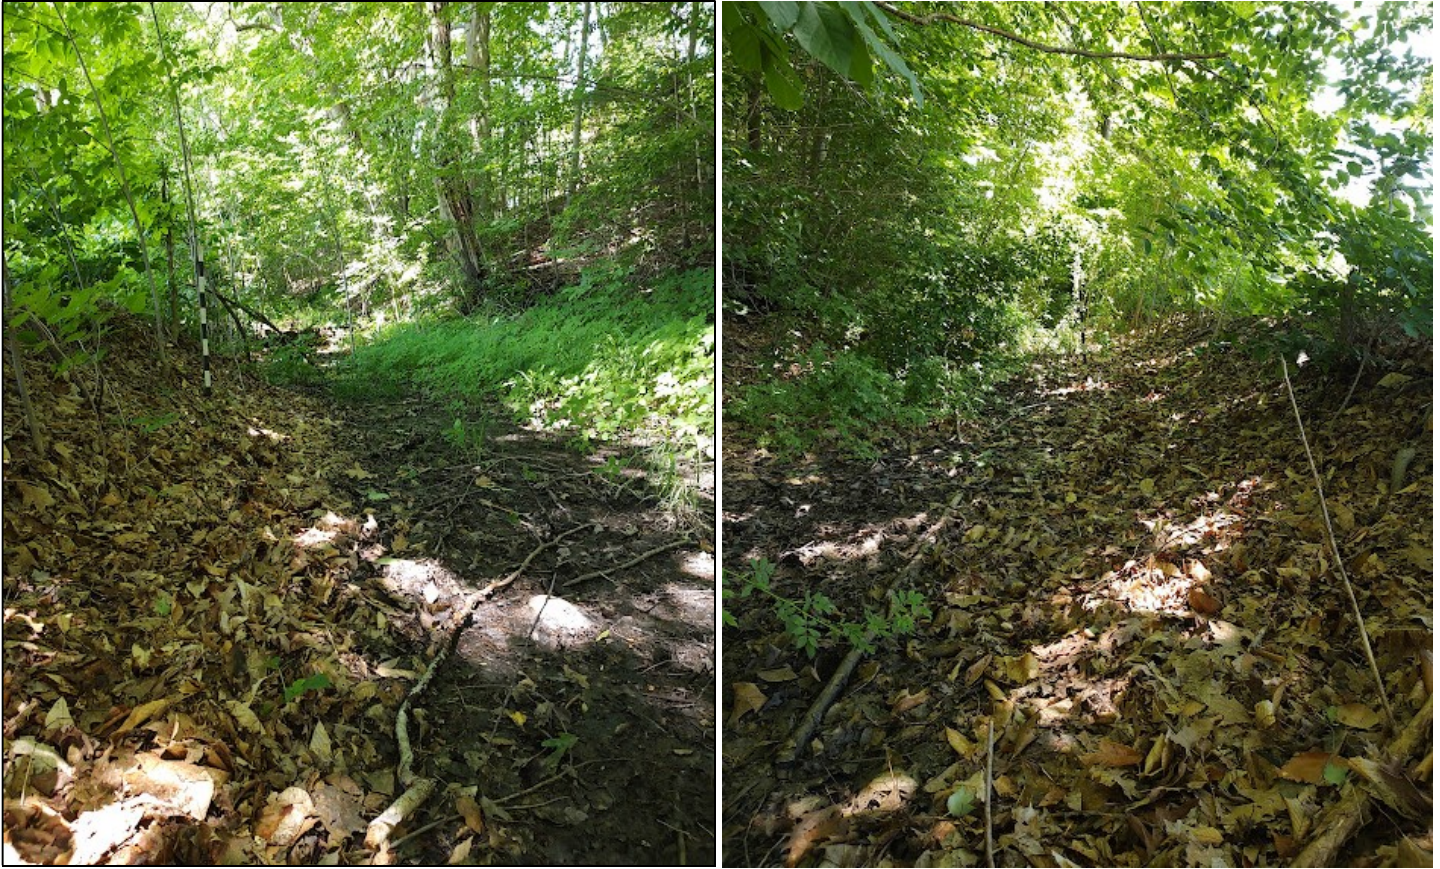
Upper Mill River Canal and Dam Site

Views from inside the canal at a point northeast of the pavilion building. Left: looking west-northwest (325°). Right: looking southeast (146°). These photographs illustrate the typical mud and leaf litter inside the canal. At this point the canal measures 24 feet in width from the top of the berm straight across to the northern slope. Eric Johnson June 19, 2023.

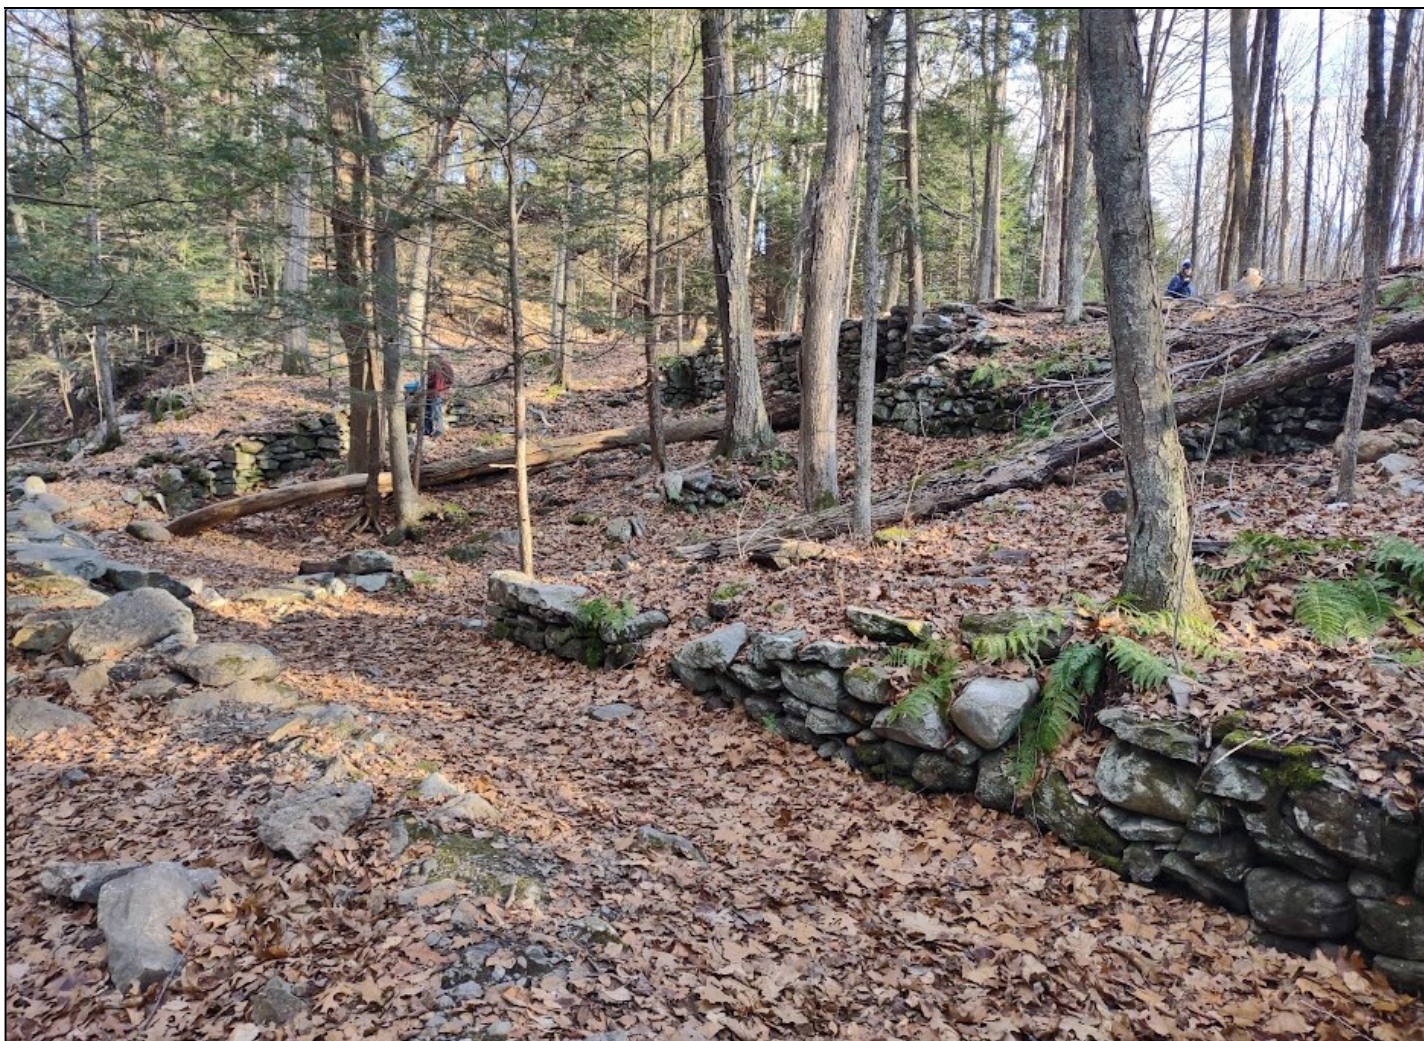
Looking east at the eastern part of the Upper Roberts Mill site. This photograph illustrates the flat terrain of the northern part of the site, the slope up to the south of the southern part of the site, and the flat area at the top, where pedestrians can be seen. Eric Johnson, November 19, 2022

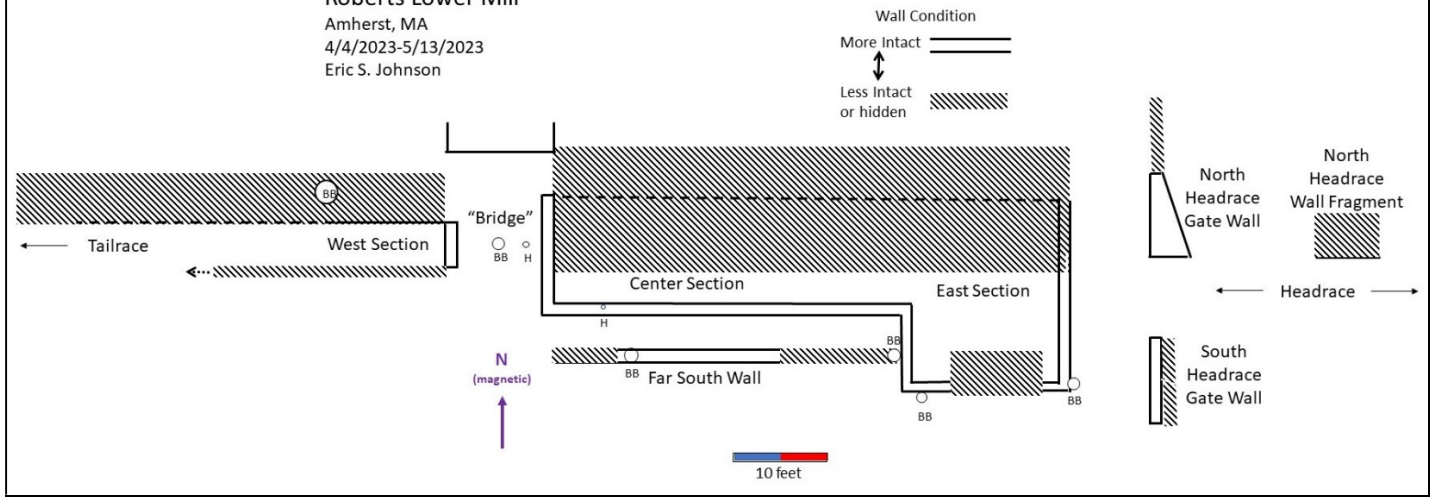
Map of the Lower Roberts Mill site showing visible walls and trees

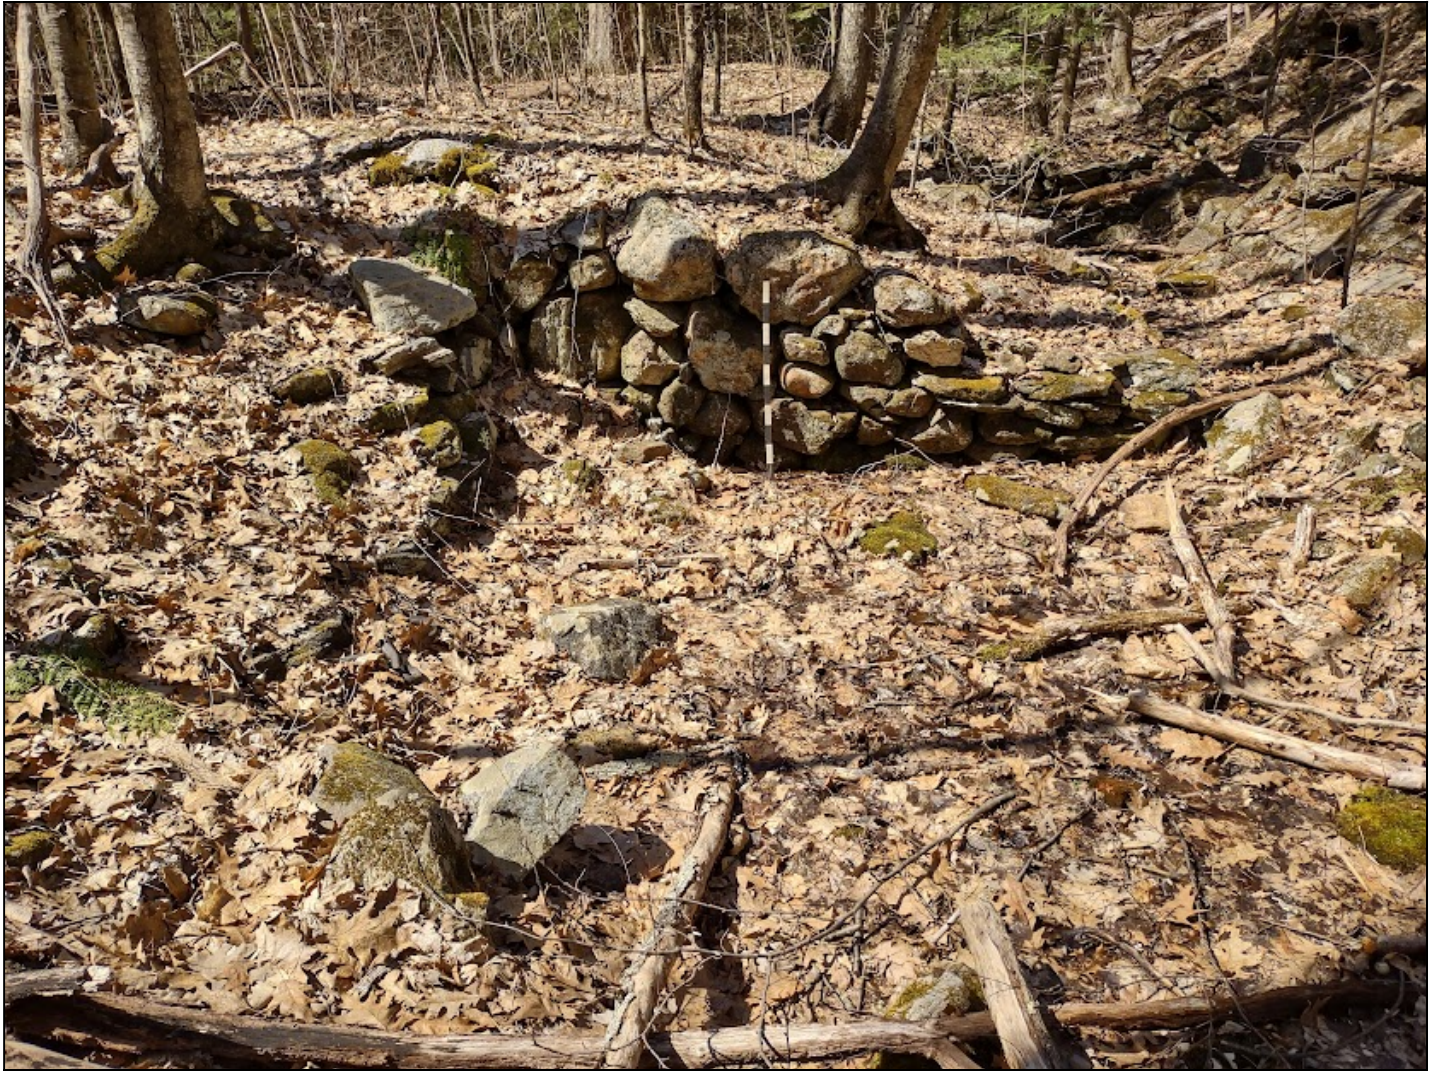
Looking west at the west wall and southwest corner of the East Section. Note the standing wall to the south (left), the disturbed wall to the north (right), and the accumulation of leaves, stones, and branches in the center. The Center Section is visible in the upper right corner. The measuring stick is 1 meter. Eric Johnson, April 10, 2023

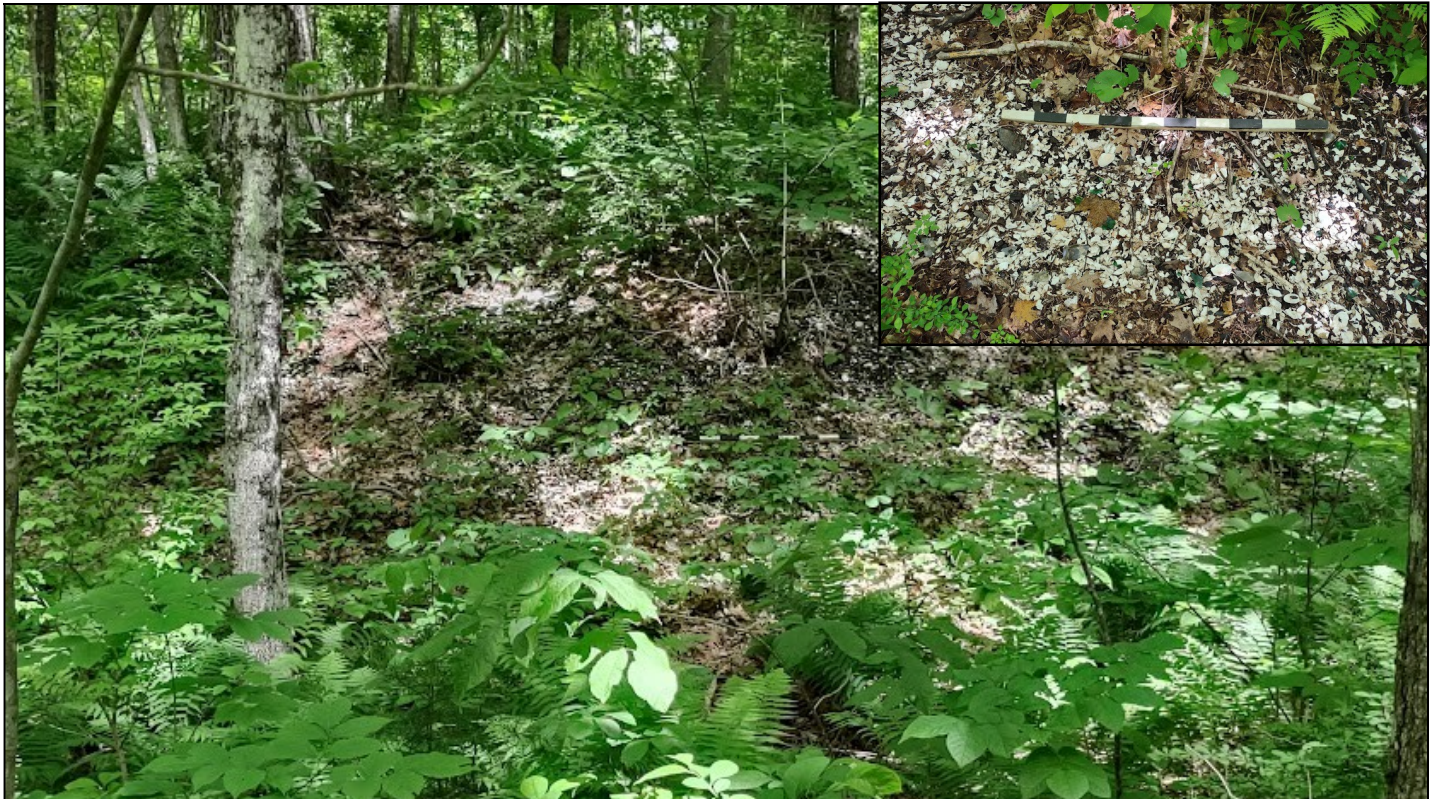
Looking east at an extensive deposit of clamshells on the slope to the west of and below the site of the former Cushman Clam Club building. Measuring stick is one meter. Inset, upper right: close up of a dense part of the deposit.
 Eric Johnson, June 13, 2023.
