Archaeological Reconnaissance Survey  
of Four Archaeological Sites  
on the Upper Mill River/Cushman Brook,  
Amherst, Massachusetts  
Volume II: Figures

Eric S. Johnson and Kathryn Curran

Prepared for the District One Neighborhood Association  
(DONA)

June 2023

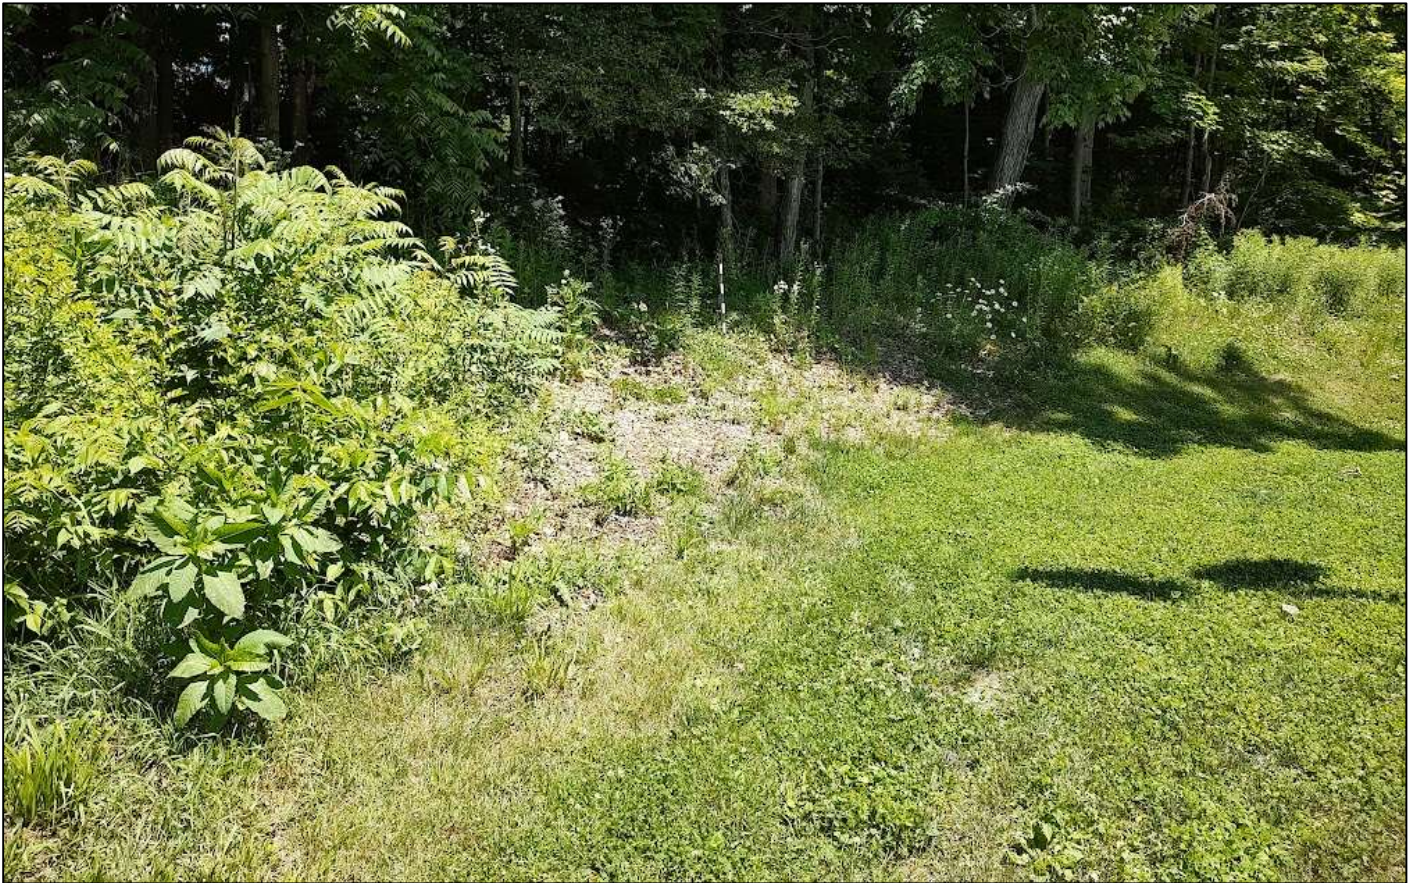
Figure 29. Looking northeast at the berm from the northeast corner of the north parking lot, next to the basketball court. At this point, the left part of the picture shows the berm at its highest. It also protrudes to the south. It is possible that the height and position reflect the addition of material during construction of the nearby parking lot and basketball courts. The right side of the photo shows the berm lower and farther north.

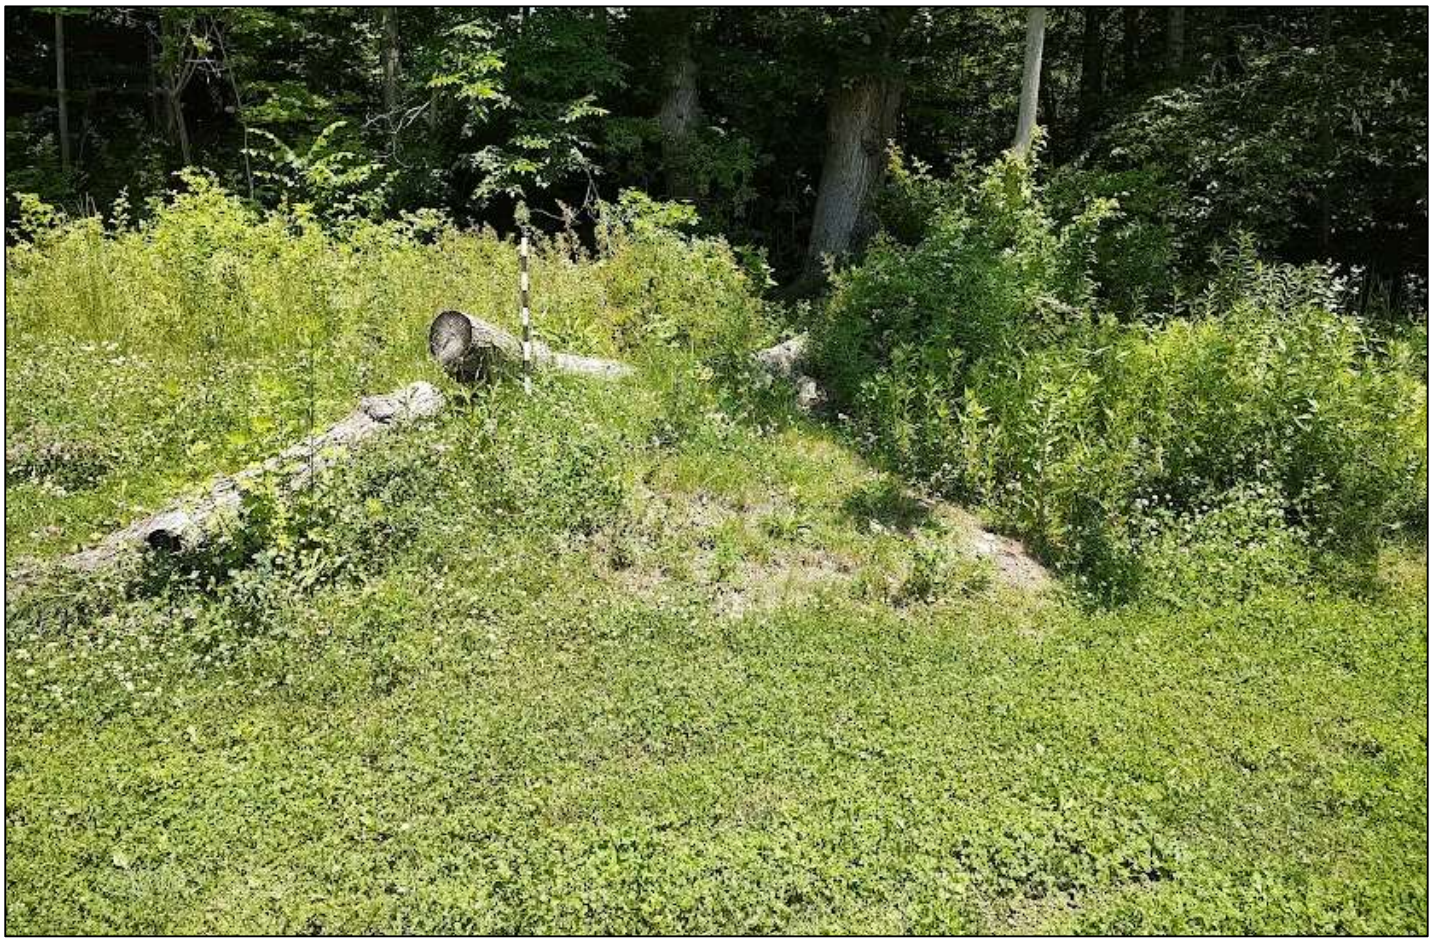
Figure 30. Looking northeast at the berm from the northwest corner of the eastern basketball court. To the right of the measuring stick, the berm has been disturbed.

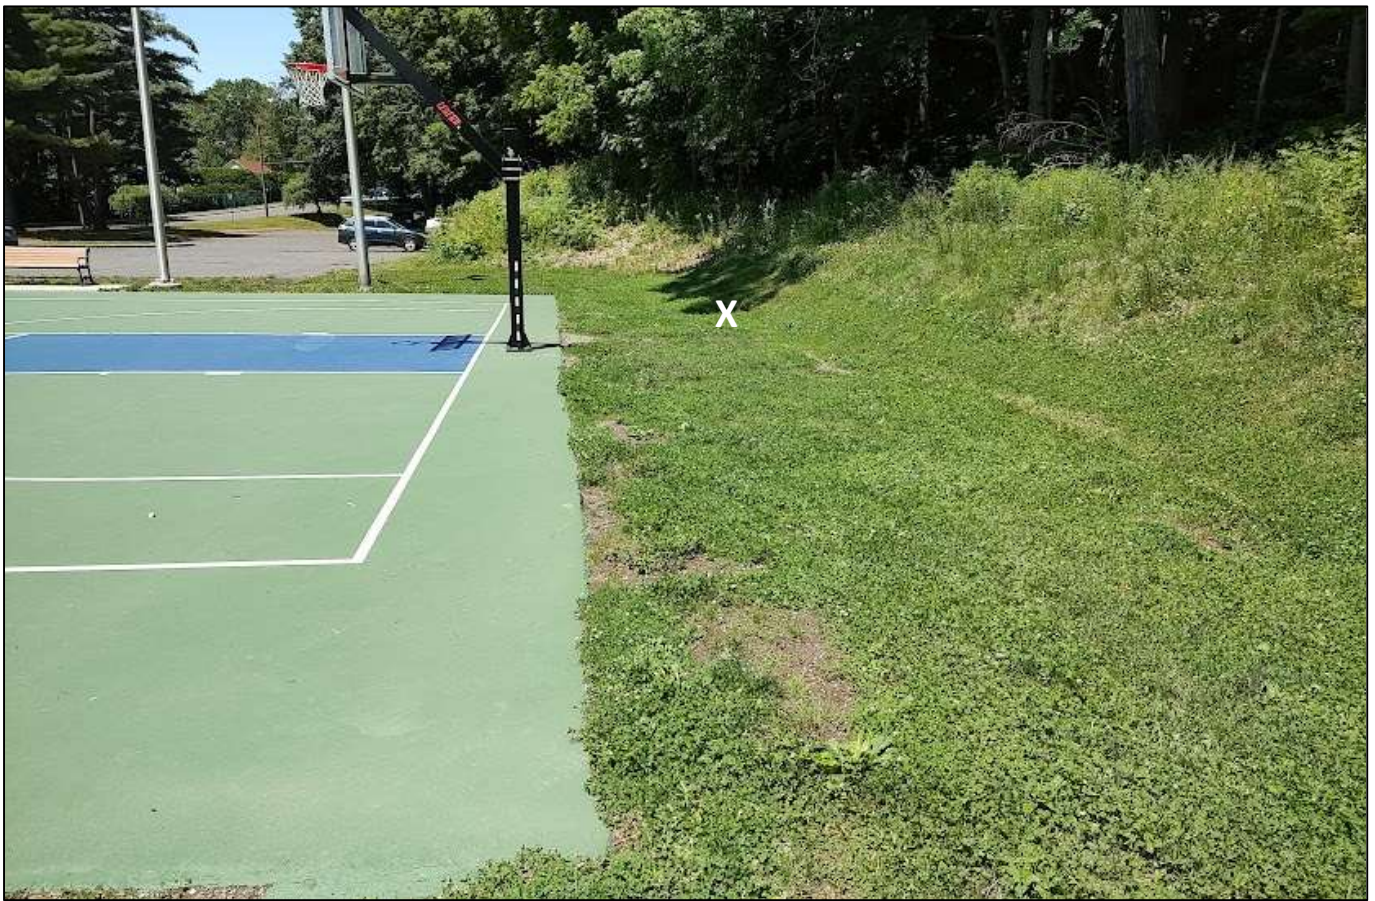
Figure 31. Looking northwest at the berm from the northwest corner of the eastern basketball court. This view shows how beyond the northwest corner of the western court, the berm extends to the south and is higher than in the foreground to the right and below the prominent tree shadow marked with an X.

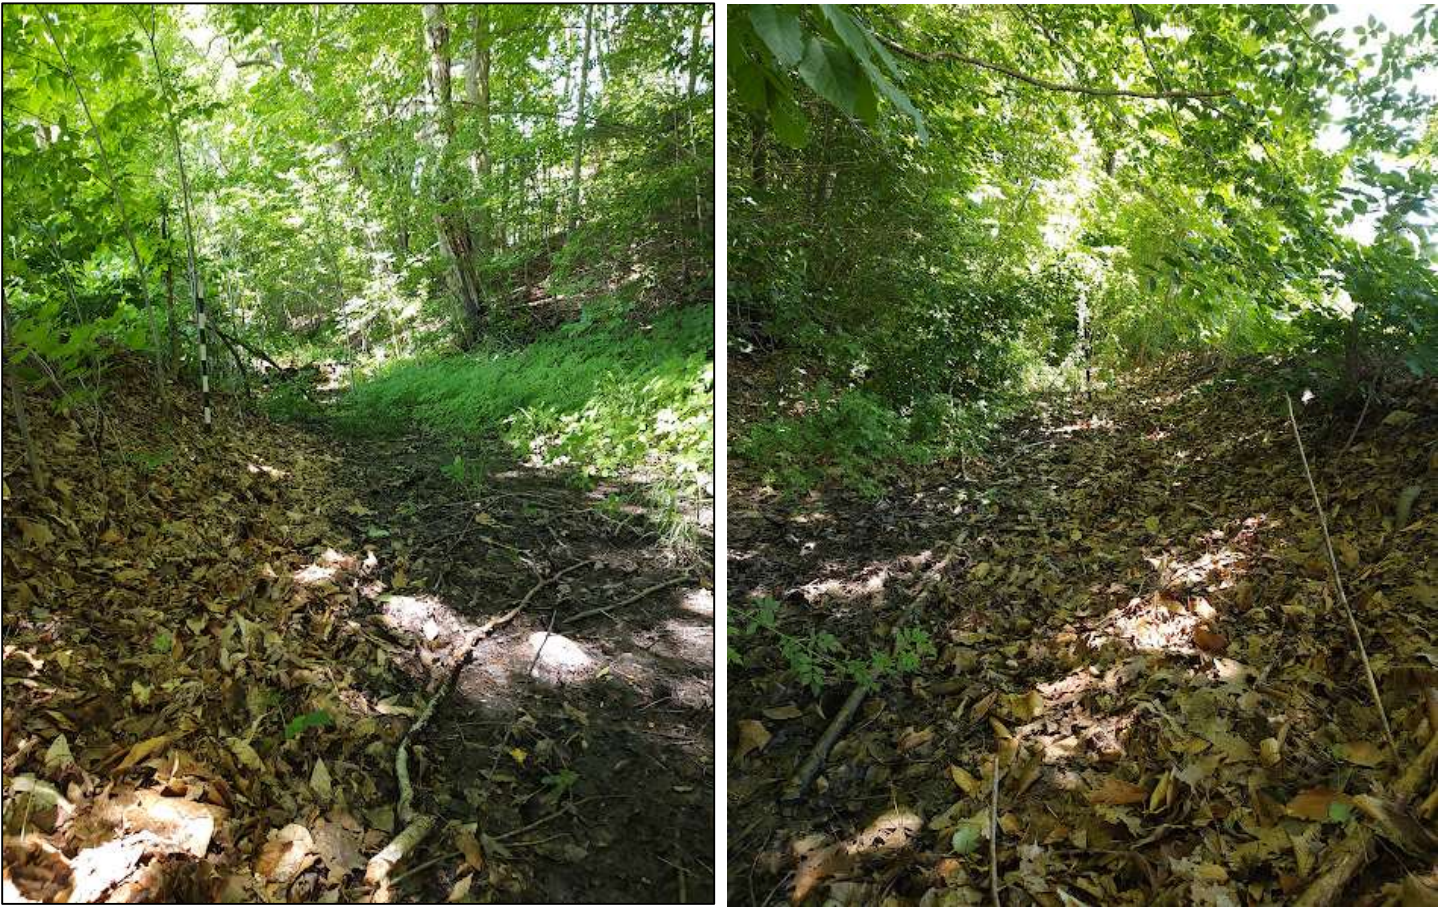
Figure 33. Views from inside the canal at a point northeast of the pavilion building. Left: looking west-northwest. Right: looking southeast. These photographs illustrate the typical mud and leaf litter inside the canal. At this point the canal measures 24 feet in width from the top of the berm straight across to the northern slope.

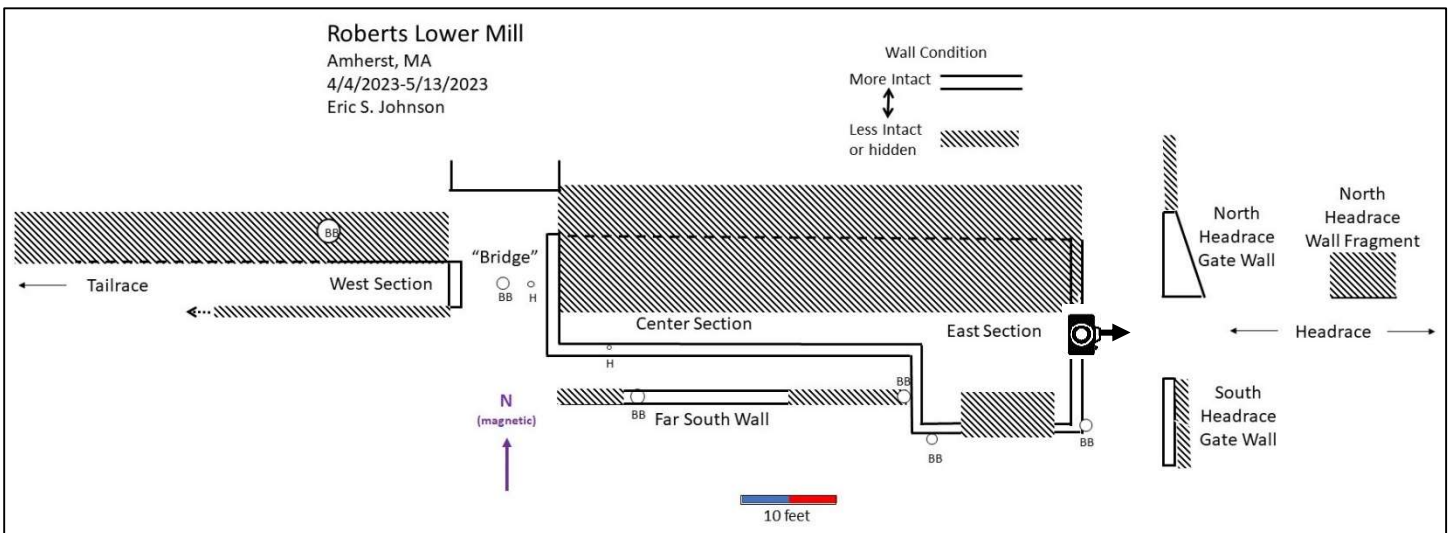
Figure 81. Looking east along the Headrace from its west end. Parts of the Headrace Gate Walls are visible to the left and right foreground.

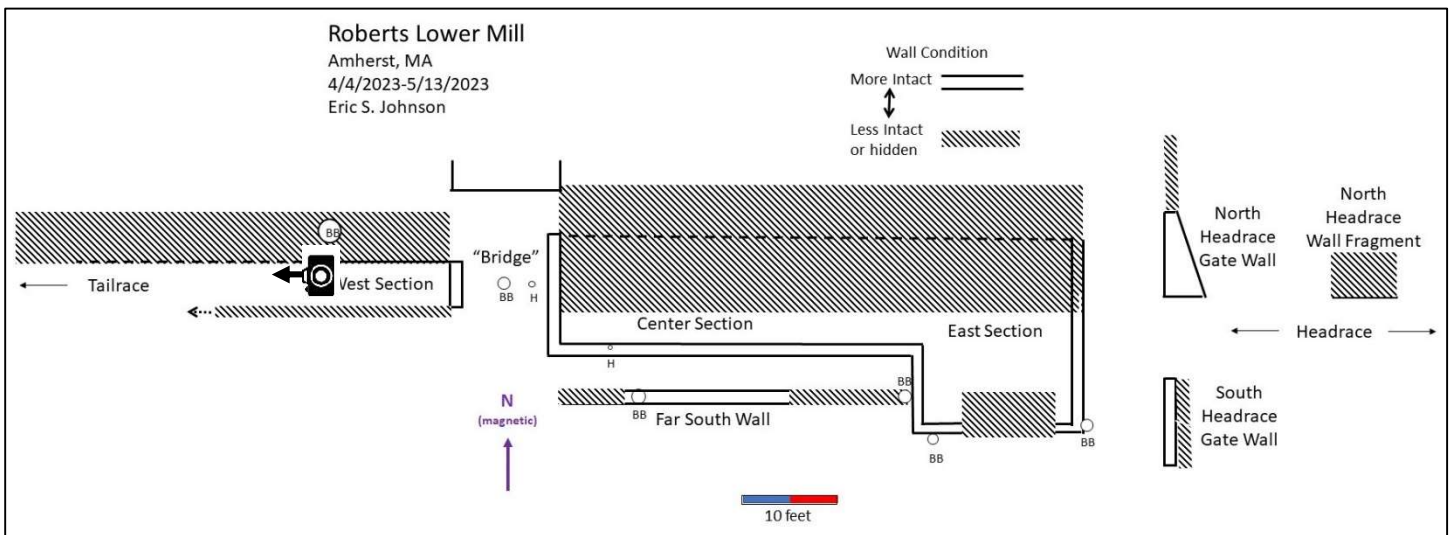
Figure 82. Looking west along the tailrace of the Lower Roberts Mill site showing standing water, many downed trees, and scattered apparently intact remnants of a former stone wall.

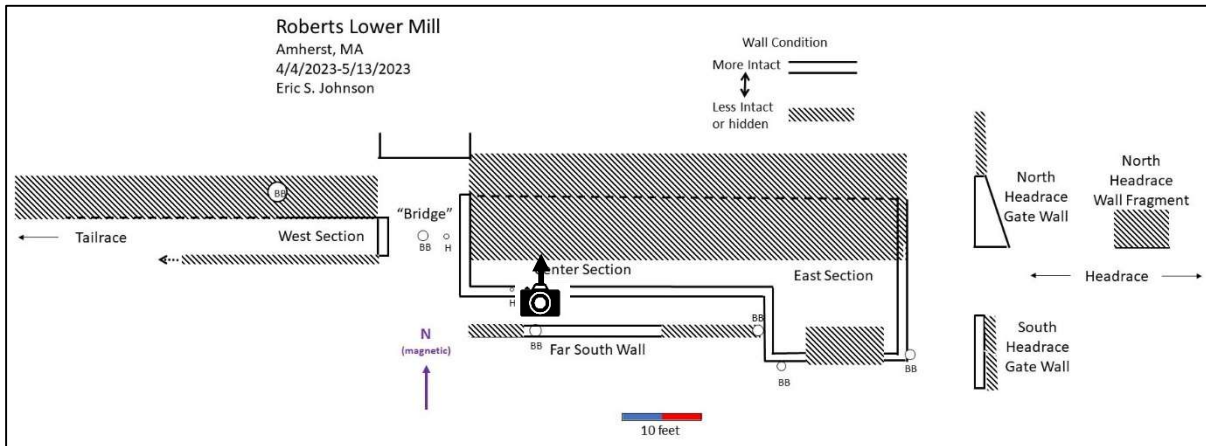
Figure 83 looking north at the north side of the Center Section showing standing water and disturbed stone wall.

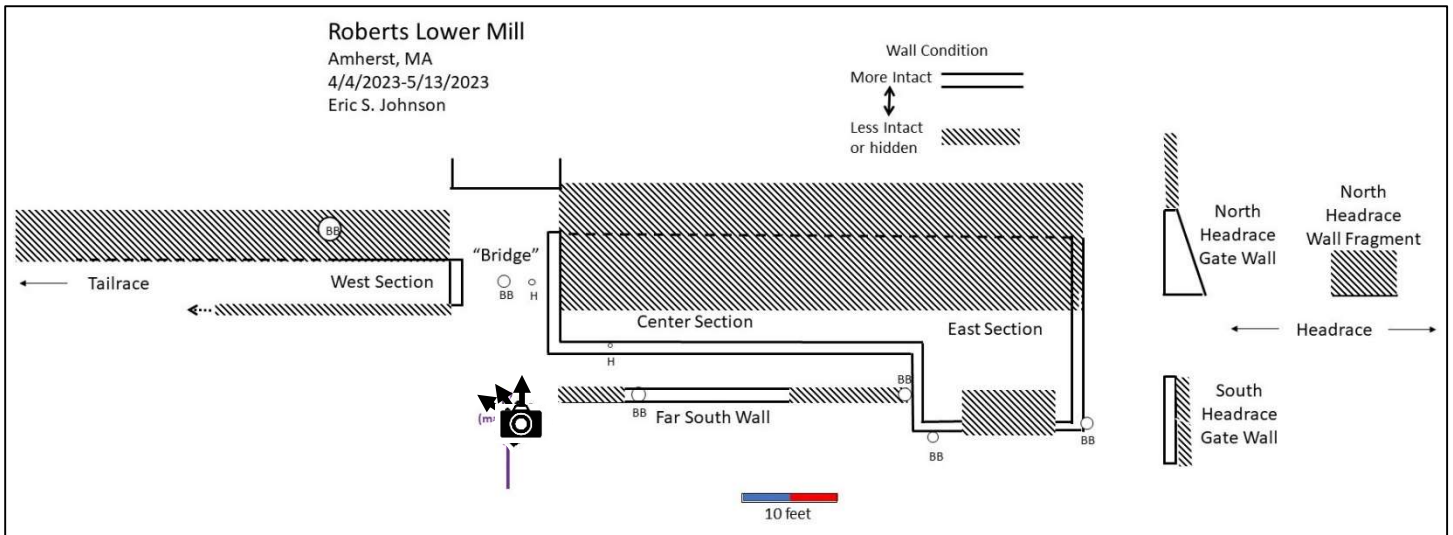
Figure 84. Composite of three photographs looking north, northwest, and west-northwest at the West Section. The disturbed condition of all but the eastern end of the north wall is evident, and any stonework that may have existed along the southern wall, apart from the eastern end, is not visible.

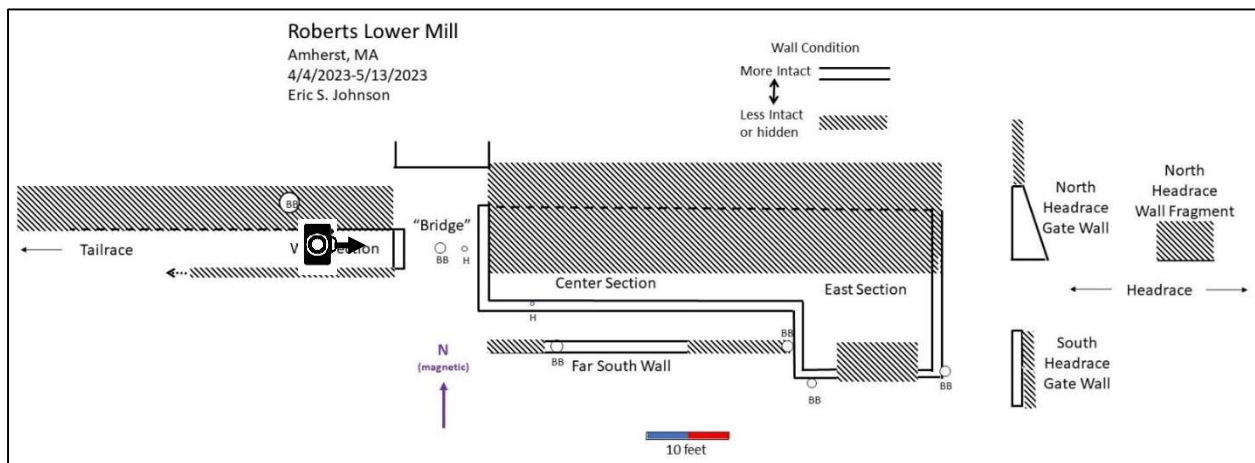
Figure 86. Looking east at the eastern end of the West Section. This is the least disturbed part of the West Section.

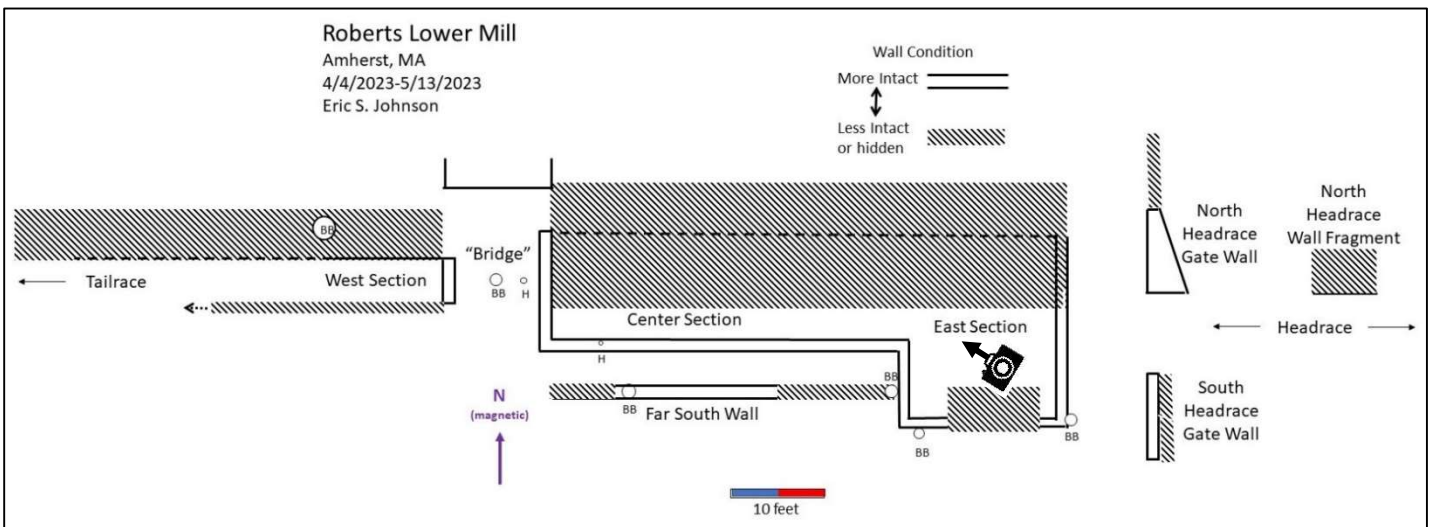
Figure 93. Looking northwest at the area between the Center and East Sections. Note the disturbed nature of the north side of the East Section in the right side of the photograph.

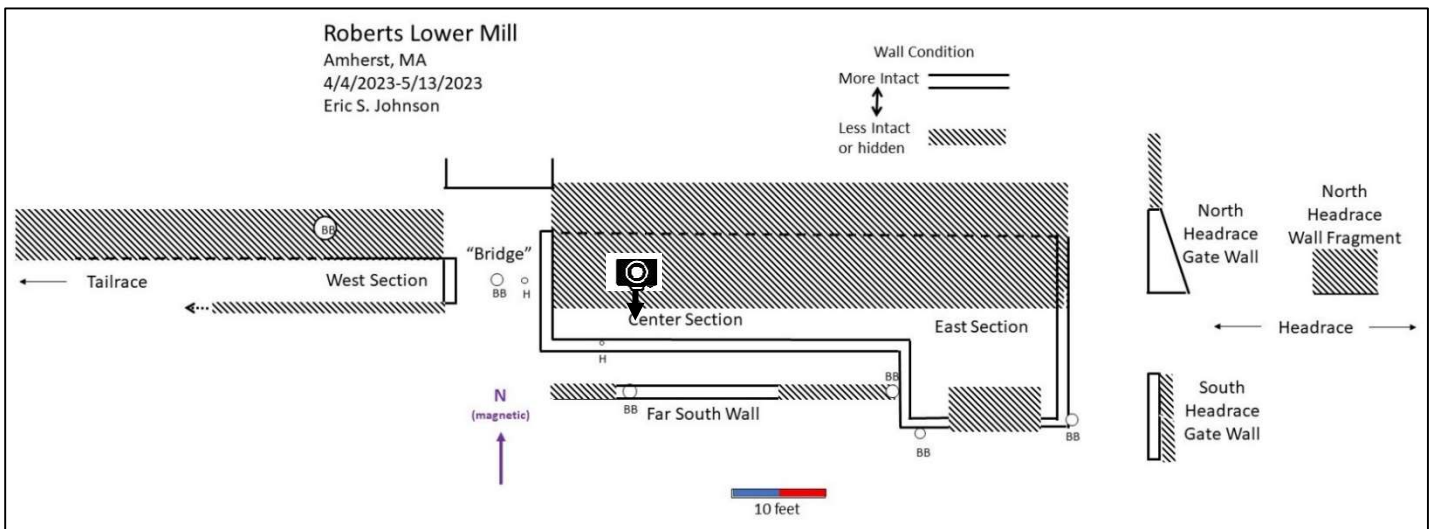
Figure 94. Looking south at the far south wall. The wall's highest point (1½ feet) is atop the large flat stone marked with an X.

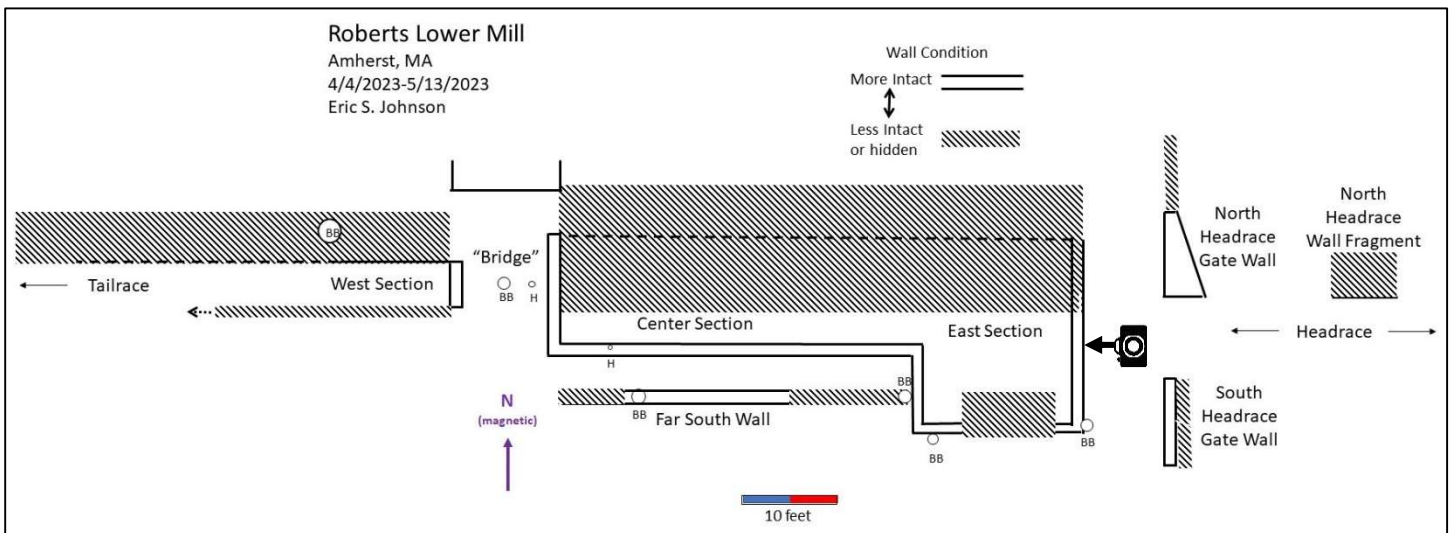
Figure 96. Looking west at the west wall and southwest corner of the East Section. Note the standing wall to the south (left), the disturbed wall to the north (right), and the accumulation of leaves, stones, and branches in the center. The Center Section is visible in the upper right corner.

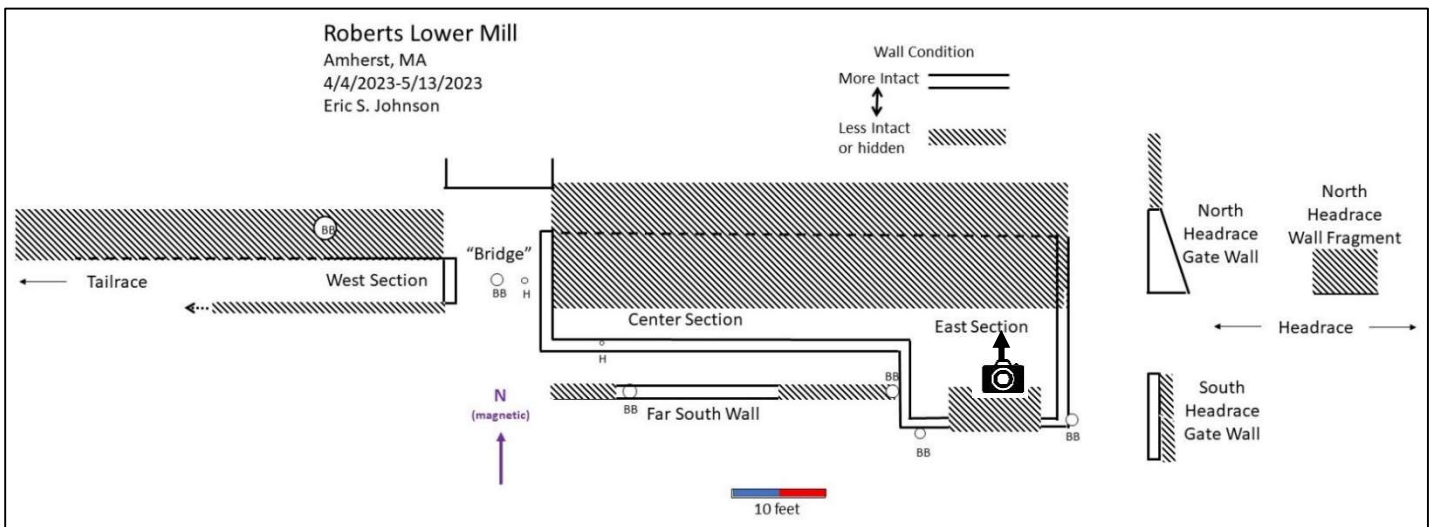
Figure 98. Looking north at the north side of the East Section showing the disturbed nature of this side.

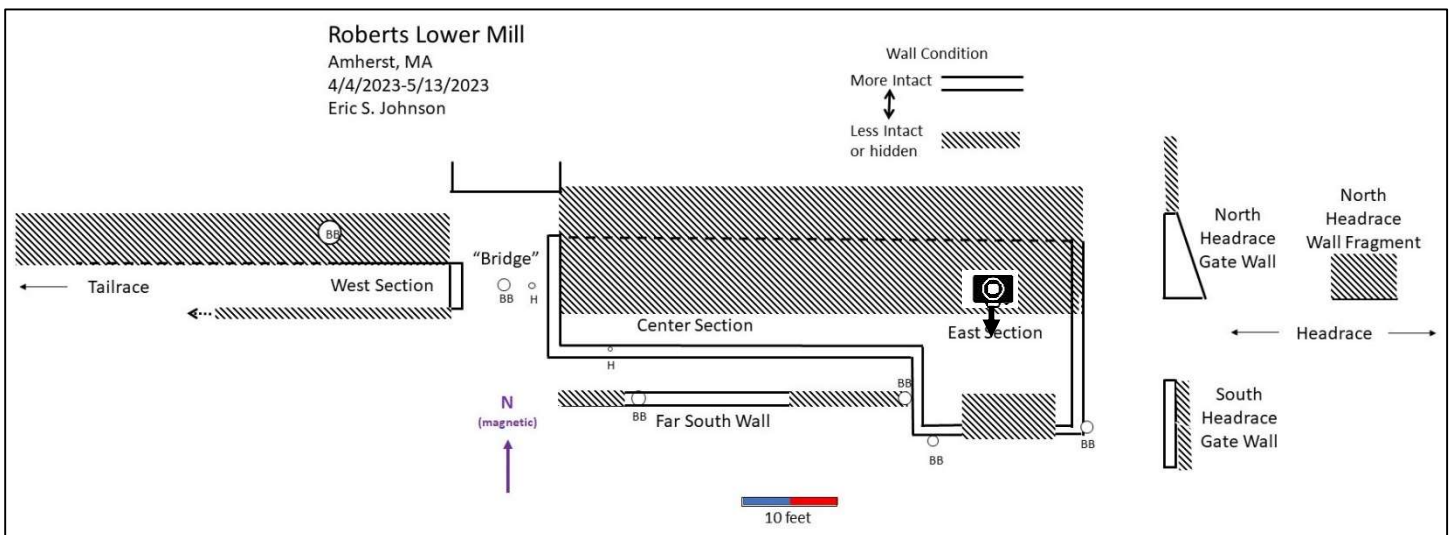
Figure 99. Looking south at the south wall of the East Section. The middle is deteriorated while the east and west ends retain more integrity. A lower wall appears to be backed by a higher wall.
